Stress Distribution as a Cause of Industrial Steel Chimney Root Section Failure

This paper has studied failure initiation of the root section of 60 m tall industrial steel chimney. Cracks that occurred in steel wall of the wind shield have significantly influenced integrity of the structure. Analytical and numerical analysis of failure occurrence was performed. Location of extreme stress values in the steel structure were identified numerically by finite element method. Identified locations coincided with the location of the cracks initiation. The results of analysis identified causes of the failure initiation and allowed expression of the recommendation for root redesign and further maintenance procedures.

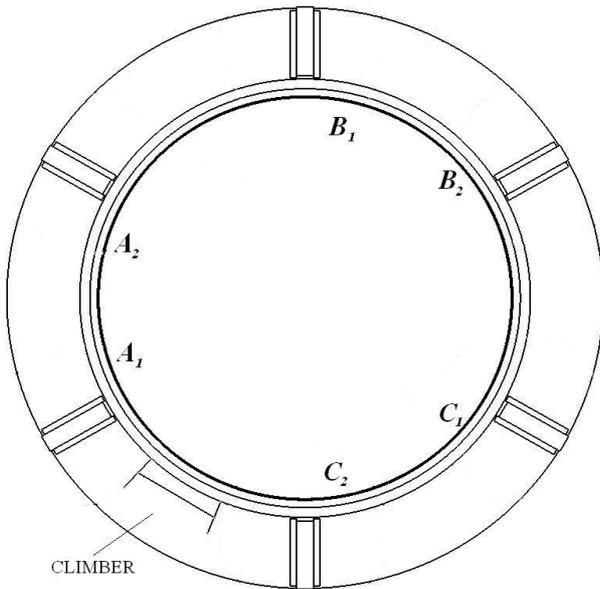
Figure 4. Top view of cracks dispositions

- A total of six cracks are initiated at root segment of chimney structure;
- All cracks are initiated on the upper corners of flue duct entries;
- Two cracks are longer than 400 mm with varying propagation direction at outer wall;
- Four cracks are shorter than 100 mm with vertical propagation direction at the outer wall.

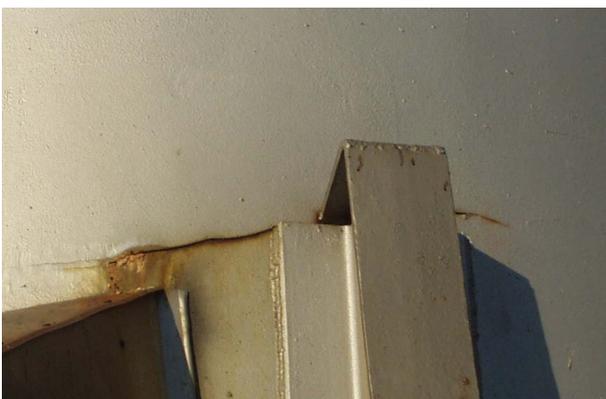
Figure 5. Crack A₁

Largest crack (A_1) is initiated at the upper right corner of flue duct entry located on the left side of the climbing ladders, Figs. 4 and 5. From its origin it propagates first upward, following the welding seam, and then making a sharp turn toward the stiffening rib top, where it continued to propagate above and beyond it. At the time of visual inspection this crack measured 650 mm.

Propagation of all six cracks also continued on the other side from their initiation points over corresponding edges of flue ducts which are not considered as the part of the outer wall structure, Figs. 5, 6 and 7.

In order to secure safe operation of the chimney, steel plates containing cracks should be replaced prior to redesign.

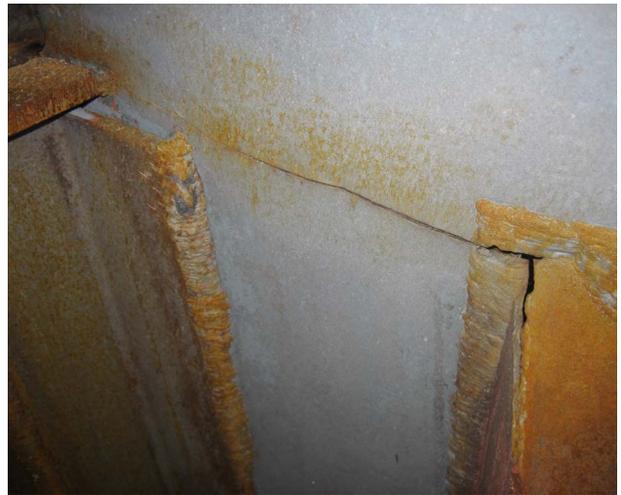
Figure 6. Crack C₂

Figure 6 shows the crack (C_2). It is initiated at the upper left corner of flue duct entry located on the right side of the climbing ladders, Fig. 4. From its origin it propagates toward the stiffening rib top ending just before it. At the time of visual inspection this crack measured 410 mm.

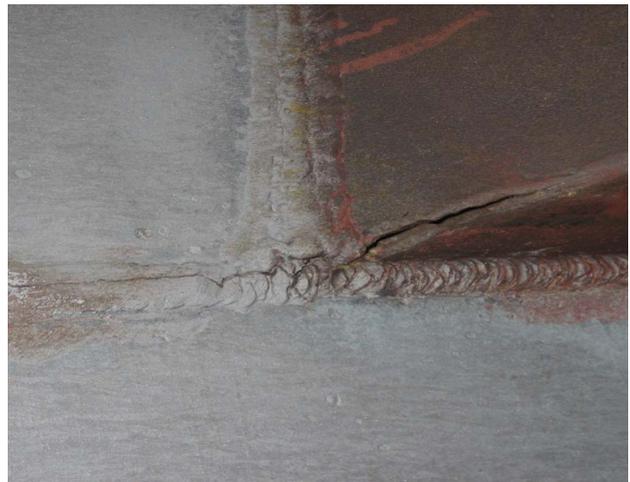
Figure 7. Crack A₂

Four cracks are initiated at the remaining top corners of flue duct entries. These four cracks are similar to each other and Figure 7 shows crack (A₂) as their typical representative. From initiation point, these cracks propagate upwards following the welding seams. All of these four cracks are less than 100 mm long.

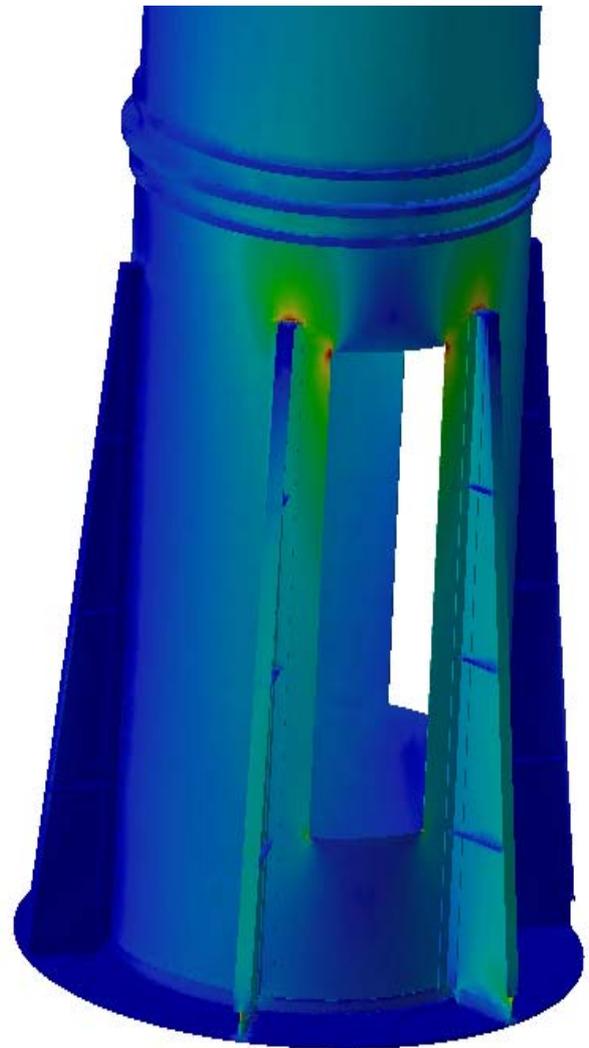
Figure 11. Uniaxial stress field on the chimney's root segment

The uniaxial stress field obtained according to the Huber-Hencky-Von Mises hypothesis for the root section of the chimney is shown in Figure 11 and for the rest of the chimney structure.

- The stress state levels in the regions around the upper corners of flue duct entry opening and in the regions around the top of the stiffening ribs are very high;
- These values of uniaxial stresses are exceeding the values of uniaxial stresses exceeding the yield stress of the material;
- Maximum stress value calculated using linear FEM analysis indicates that the stress concentration factor is 6.2 in the vicinity of the flue duct entry opening upper corners;
- Zones of high stresses values in the region around the upper corners of flue duct entry opening and the top of the stiffening ribs are adjacent;
- Calculated uniaxial stress field indicates considerably lower stress state levels in the rest of the chimney's root.

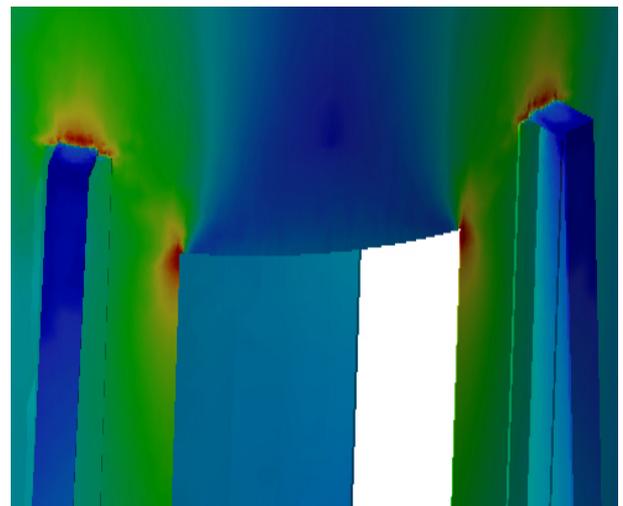
Figure 12. Distribution of the uniaxial stress at the zone of flue duct upper corners

Maximum values of uniaxial stress are obtained at the chimney's root section in the zones next to the upper corners of the flue duct entries, Fig. 12. High values of uniaxial stress are obtained at the outer wall just above the stiffening ribs.

These factors have caused highly uneven stress distribution in the two cross-sections of the chimney. Prompt incursions of the stiffening rib have as a consequence high stress level state just above them. Sharp corners of the flue duct openings without reinforcements along their edges, result in stress concentration at top corners.

The identified high level stress zones conjugated with detrimental effects of the welding seams ending at the top corners are principal causes of the structure failure occurrence.

- elimination of the high stress concentration zones,
- even redistribution of stress field in the root section of the chimney,
- reinforcement of the flue duct openings at the outer wall,
- significant reduction of stress level in the proximity of welding seams, and
- enhanced protection against corrosion.

Installing of the flue duct opening reinforcement should eliminate high stress concentration zones from the vicinity of the opening corners, therefore dislocating higher stress concentration zones further from welding seams ends. Redesign solution should reconfigure chimney structure near the level of the top of the stiffening ribs to achieve evenly distributed uniaxial stress field in their vicinity. Maintenance procedures should be conducted on regular basis.
