# A Case Study on Damage Detection of Wind turbine Composite Blade

**H.S. Sunil Kumar**

**R.B. Anand**

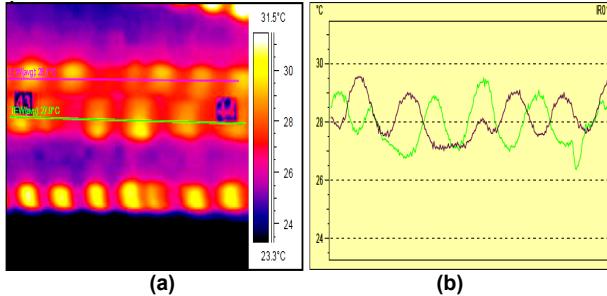
**Figure 5. Inspection of adhesive joint showing, (a) Infrared image of spot curing glue defect and (b) bar graph showing temperature variance.**

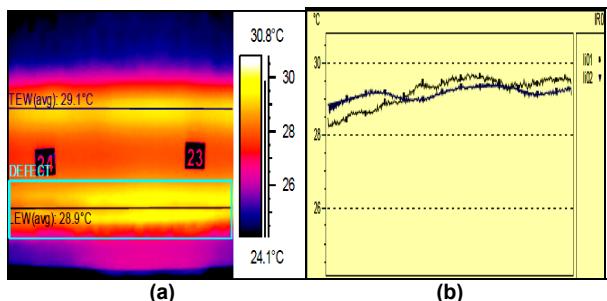
**Figure 6. Inspection of adhesive joint showing, (a) Infrared image of dry glass defect and (b) bar graph showing temperature variance.**

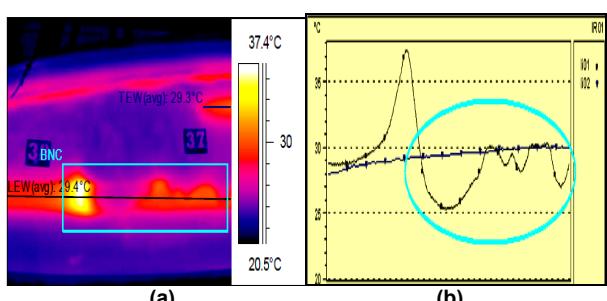
or uncured bond. Fig. 8a shows the discontinuity in the colour coding in between sections 37 and 38. The presence of the wet glue reflected in the significant change in the temperature between the two bond lines which is shown in Fig. 8b. Like this the defects observed at each section are noted down and are repaired at this stage by making use of thermographs obtained [28,29]. In a similar work, Rasuo [30] conducted the inspection of helicopter rotor blade using acoustic emission and infrared thermography to check delamination or permanent deformation before and after fatigue tests.

**Figure 8. Inspection of adhesive joint showing, (a) Infrared image of uncured bond and (b) bar graph showing temperature variance along bond line.**

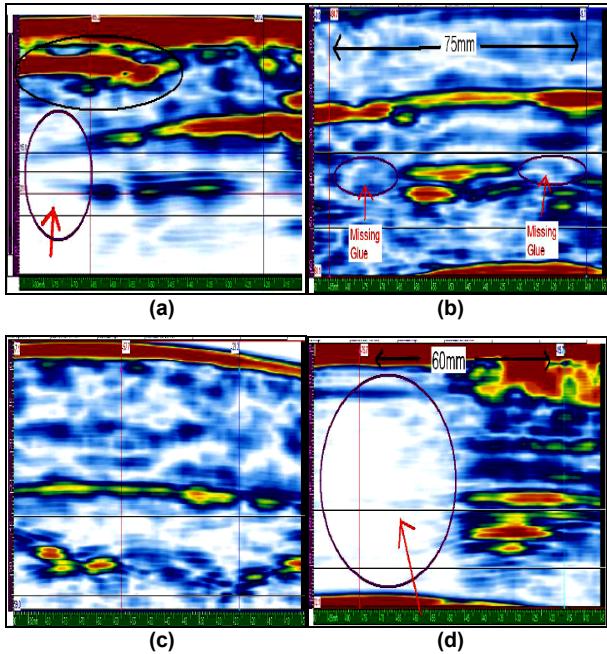
In next stage of inspection we have performed ultrasonic testing of adhesive joints between main webs and blade shell. Here both the upwind and downwind blade shells are inspected along entire length to check the web bond lines. The principle of ultrasonic testing is when ultrasonic waves are transmitted into the composite material the internal defects like disbanding or delamination influence the wave propagation resulting in local change [31,32]. Fig. 9a - d shows the scanned images of various defects found in the glass reinforced plastic composite blade. Fig. 9a shows the scanned image of particular section of blade displaying improper placement of web. The web was not placed in proper position or it might have shifted the position while fabrication process. So we can see from the image that there is a loss of signal due absorption of signal by balsa wood (shown by red arrow mark). The loss of signal was mainly due to resting of web over the blade shell balsa in the laminate. We can see the laminate signal above the balsa wood on the left side of the scans but there is no true signal below it. In case of Fig. 9b, we can observe that the case of narrow bond, glue missing which was needed to bond blade shell. The missing glue is shown by red arrow marks in the scanned image. The minimum required length in this area is 75 mm, but when we observe the scan carefully we can find that there is no glue bonded to either web flange or blade shells to meet the 75 mm length requirement. Fig. 9c, this scanned image shows the wet glue which was earlier detected in infrared image and then reconfirmed with the ultrasonic testing. The loss of signal in this particular scan is the indication of presence of wet glue. Finally the Fig. 9d, the dry glass defect is seen in the joint area. The loss of signal caused by the dry glass is seen in the scanned image. When such defects are seen during inspection, the procedure is to rescan the defect locations again. Such defect area are marked on the blade shell and subjected to repair.

**Figure 9.** Ultrasonic inspection of adhesive joints between main webs and blade shell showing (a) Improper placement of web, (b) narrow bond, (c) wet glue and (d) dry glass

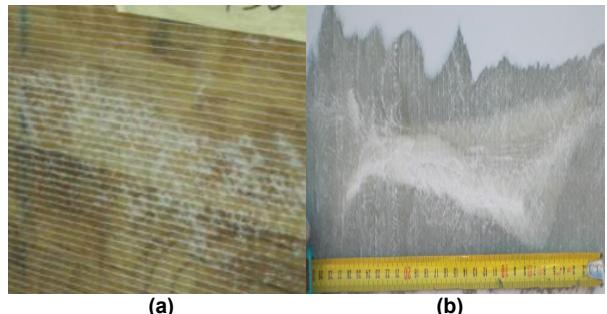
**Figure 10.** Photographs of defects identified by inspection process are (a) dry laminate and (b) wrinkle formation due to fibre disorientation.

**Grinding and chamfering:** The defects identified are subjected to grinding using grinder which removes all the damaged laminate. It is necessary to remove the dry glass at glass fibre pultrusion pieces or triangles and then ground off. This is followed by chamfering of damage in which grinding the chamfers in the rectangular shape is done as shown in Fig. 11a. The chamfering is done in such a way that it should be even and the deviation should not be greater than 1 mm. The surface as mentioned should be even and checked using 300 mm surface plate or a steel ruler. If the surface is not even than it has to undergo re-grinding for smoothness.
