# Investigations on the Oxidation of Zn-coated Steel Cables

*The automotive component industry has been constantly being studying to improve its performance. Bowden cables are present in opening doors, moving windows and others. In braided cables formed by galvanized wires with Zn steel exposed to the usual environmental conditions, the generation of ZnO appears, a phenomenon known as "white corrosion". The investigation consisted of mitigating the causes of the ZnO formation. Scanning electron microscopy (SEM) and Electron Probe Micro-Analyzer (EPMA) technology, allowed to detect that the generation of ZnO was induced by the presence of nucleating elements of ZnO on the surface of the steel cable before galvanizing with Zn. The S, Cl and O became visible in the interface between coating and substrate. This allowed concluding, under the coating, there were harmful products capable of triggering the ZnO nucleation reaction. So, the storage and cleaning of the steel wire before galvanizing is essential to prevent the ZnO formation.*

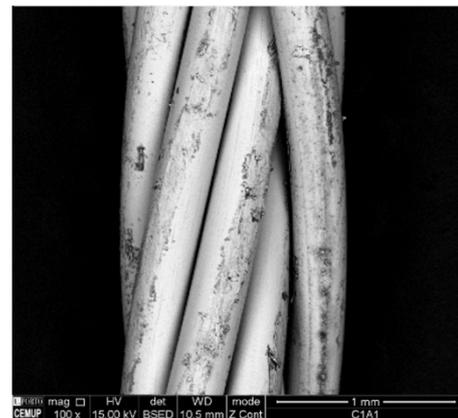
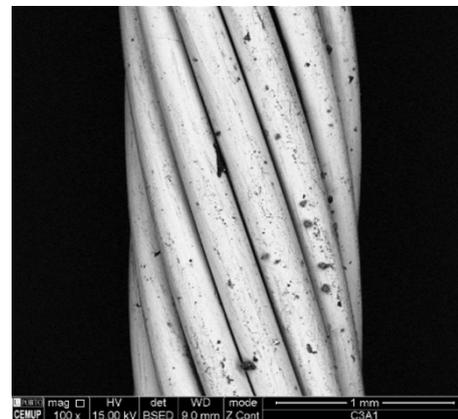
**Figure 2.** Two new cables in area 1, (a) CN1A1 and (b) CN3A1.

After the observations made by SEM, and analyzing the three cables in area 1, it was possible to observe that:

- No corrosion was detected in area 1.
- In areas not affected by corrosion, the presence of these trails allows claiming that this fact cannot be considered as one of the causes of the corrosion.
- The presence of some dark stains on and between the wires, which will be shown in detail later, revealed a strong C peak, detecting or not the presence of K. It was also studied the composition of the internal polymer tube to understand if these stains could be originated by cable friction on the polymer or if it was another product. No correlations were found between the stains and the polymer tube. Possibly these stains would be leftover lubricants from the wire, which can result from the manufacturing or assembly process of the Bowden cables, where the wires are conducted by some pulleys subjected to lubrication before being cut.

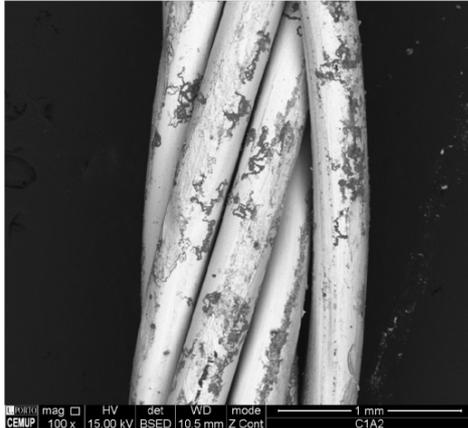
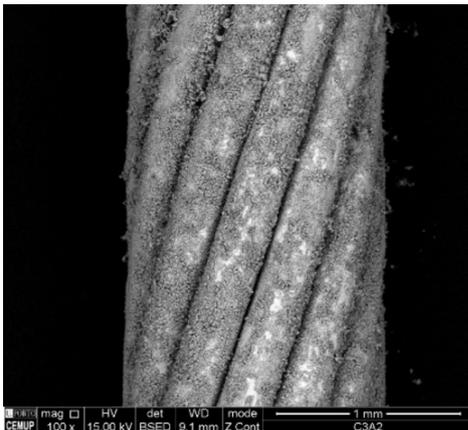
Figure 3. Two new cables in area 2, CN1A2 (a) and CN3A2 (b).

Using SEM in area 2, on the three new cables, it was possible to conclude the following:

- The studied samples behaviour, from the same area, but from different cables, were very different.
- The presence of lubricant in the samples, in this area, was zero or extremely low. This confirms that lubricant found in area 1 provides accidentally from contact with the mechanical devices allocated to the manufacturing and assembly operations of these cables.
- Cable 2 showed some small ZnO aggregates. Cable 3 showed a uniform layer of fine ZnO formation, which easily leaves the wires as white

- The adhesion of some small clusters of ZnO was very poor. It was possible to see the weak contact of the Zn surface layer with the substrate, particularly in cable 3, see figure 3.
- The ZnO appeared around all the wires. This phenomenon did not appear just on the external cable area. Thus, this suggests that ZnO formation is not induced by contact with any external body, being a problem induced by the environment where the single wires or the metallic cable are inserted during the cable manufacturing process.

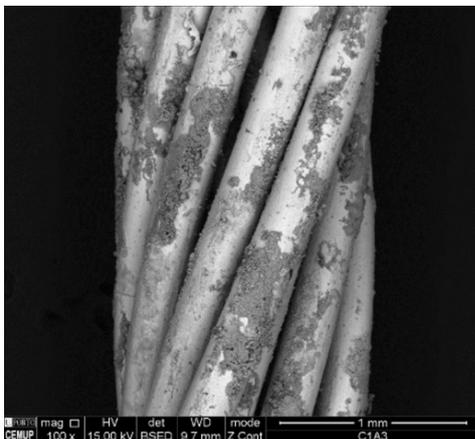
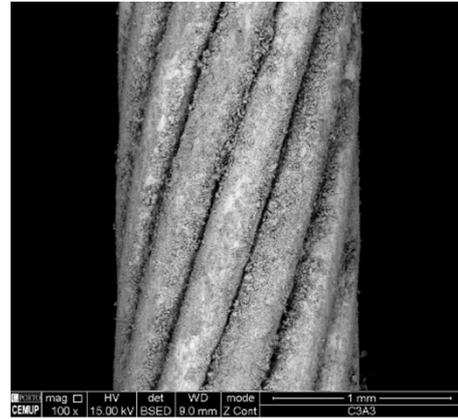
Figure 4. Two new cables in area 3, CN1A3 (a), CN3A3 (b).

After the observations of the area 3 of the cables, figure 4, it was possible to observe that:

- Taking into account the previous analysis performed on area 2, it was possible to conclude that in the area 3, just the cable 1 presented an increase in terms of ZnO formation.
- Cable 3 presented behaviour extremely similar between area 3 and area 2.
- Just cable 1 showed a consistent increase in the ZnO formation from area 1 to area 3, revealing a possible way of beginning ZnO formation.
- In a few cables, some aggregates of ZnO seemed stand-alone. These aggregates can be easily extracted when in contact with a carbon tape.

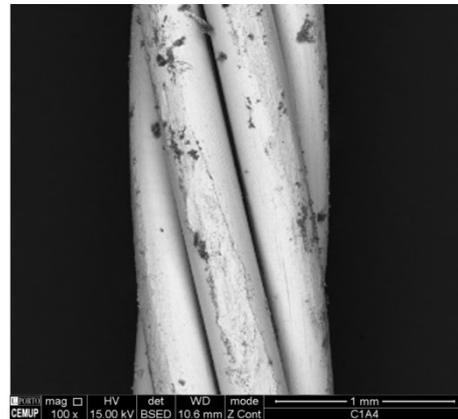
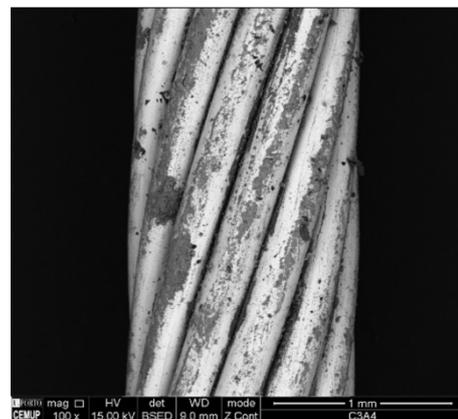
Figure 5. Two new cables in area 4, CN1A4 (a) and CN3A4 (b).

Considering the observation of area 4, as can be seen in figure 5, it was possible to conclude that in this area, the results were like in area 1, and much better than areas 2 and 3.

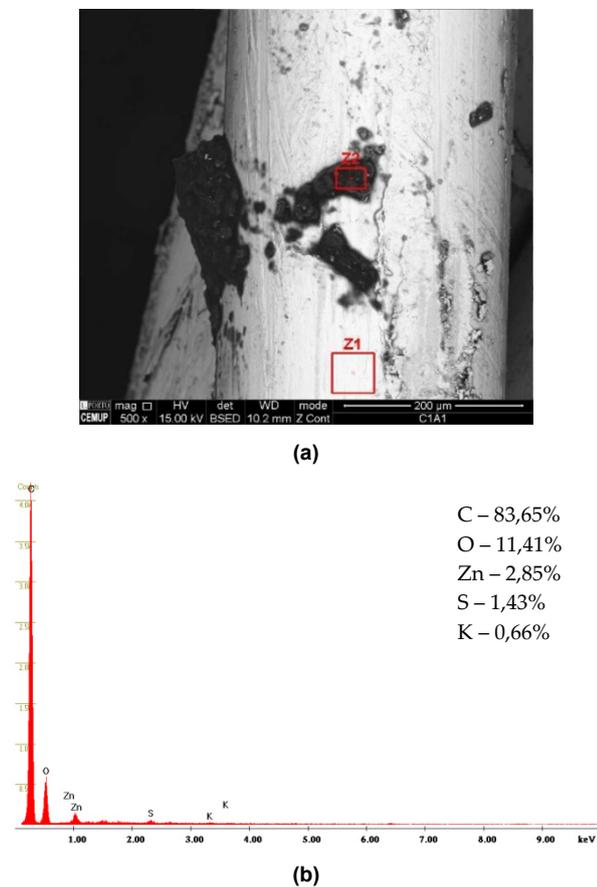
Figure 6. Dark areas on CN1A1 (a); and Zone 2 micro-analysis (b).

The areas highlighted, with Z1 and Z2 marked in figure 6 correspond to microanalyses carried out with a beam potential of 15 kV. Zone 1 corresponds to the wire coating (Zn), figure 6(a), and Zone 2 can be some lubricant or polymer substance, due to the strong peak of C, figure 6(b). Regarding the shape of the dark area, the most likely is that cable had contacted with the exterior polymeric tube and some fragments of the tube have adhered to the steel coated cable, because lubricant stains present a less defined shape. Observing

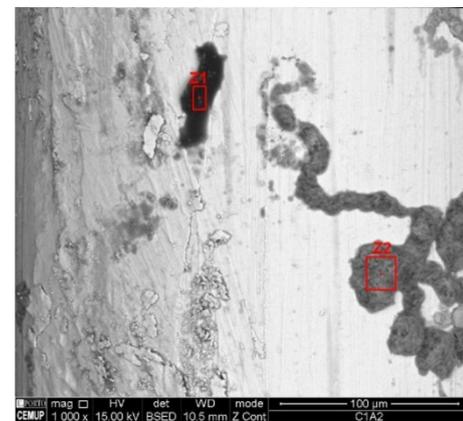
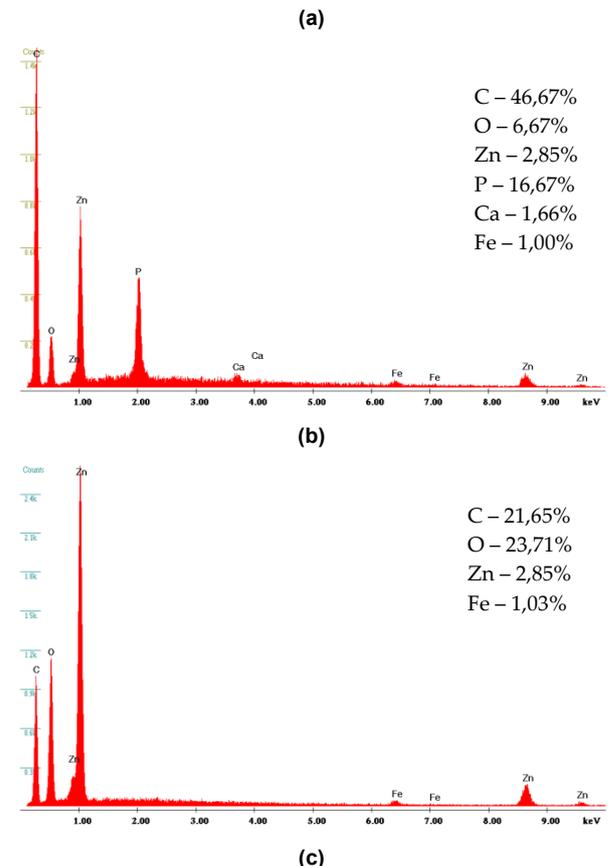
- There were two different kinds of grooves on the wire surface: the vertical and the inclined grooves. The first one, perfectly organized, generated by the wire drawing process, and the other one, randomly distributed, which cause some surface cracks.
- In these surface cracks, no ZnO formation took place or nearby them, even though the coating has been affected. Thus, ZnO formation did not seem to be related to wire protection due to Zn coating lack.
- The randomly distributed grooves and deformations did not seem to be generated by the wire drawing process, having been formed due to high stress.
- It was found that the ZnO formation took place as an external body, easily detachable under the powder form.

Figure 7. Different morphologies on CN1A2 (a) and micro-analysis zone 1 (b) and zone 2 (c).

Zone 1, figure 7b, showed the substances or C-rich and P products, strange to the wires, and in the zone 2, figure 7c, showed the presence of ZnO with an unexpected peak of C. To understand the behaviour of the dark substances in and out the trail along the cable, a fourth zone was studied, as can be seen in figure 8.

- Considering the left side of the figure 7(a), it can be observed some grooves, which may have as source one of the following mechanical processes: (a) Wire drawing or (b) Matting process. In the

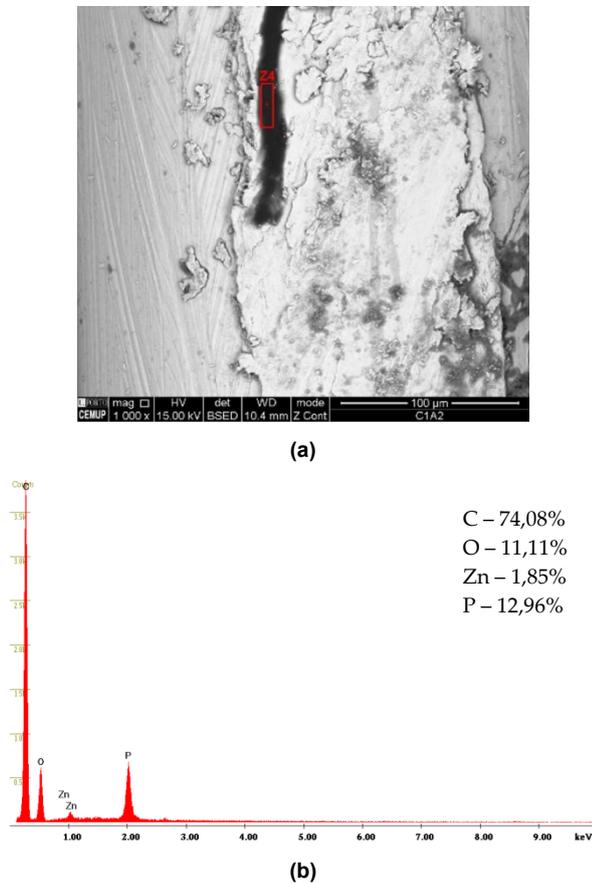
**Figure 8. Dark substance analysis on the trail, in CN1A2 (a), and Micro-analysis (b).**

- It was detected the presence of some strange substances over the wire coating, independently of the area considered.
- Micro-analysis performed allows concluding that these substances had the origin of the internal polymer tube used in this kind of pipe or from lubricant got during the cable manufacturing or assembly process. After the first analysis, the two hypotheses remained open because just C was detected. However, the second analysis led to observe that also P can be found. Hence, two situations can occur: the dark substances provided from different situations or products.

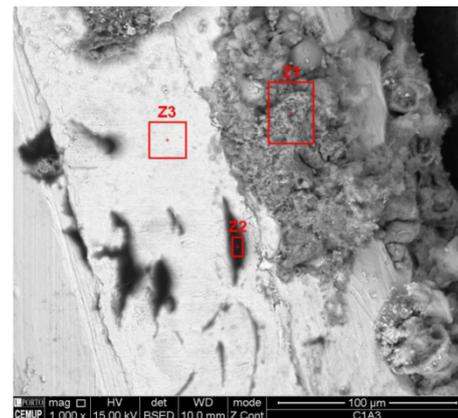
The presence of ZnO was more intense on cables 1 and 3. The figure 9 shows the first stage of ZnO formation (cable 1, area 3) generalized over the Zn coating.

**Figure 9. ZnO formation on CN1A3.**

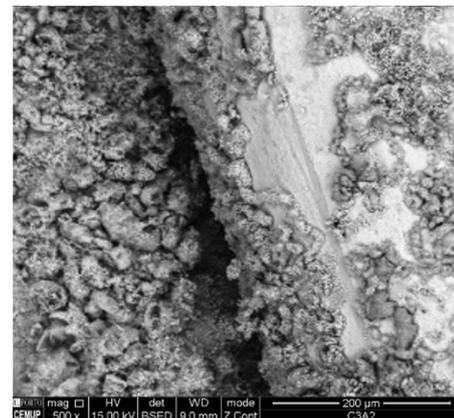
It was found that the evolution of the ZnO layer does not seem to follow any pattern, leaving some spaces to detach itself from the formation of ZnO at this stage. It was also found that there were several stages due to the different grain sizes, figure 10. After these observations, it is possible to conclude that the ZnO growth occurs around the particles themselves. In the analysis carried out, it was observed that: (a) the protection given by the zinc coating is effective because no trace of iron was found, (b) ZnO showed a continuous growth around the small crystal, but the larger these particles were, the weaker were these connections to the wire coating, (c) although the thickness of the Zn layer was not measured, the level of iron detected shows that the thickness of this layer is thick. For Fe detection, a 15 kV electron beam potential was used through the Zn layer.

**Figure 10. ZnO formation generalized stage CN3A2.**

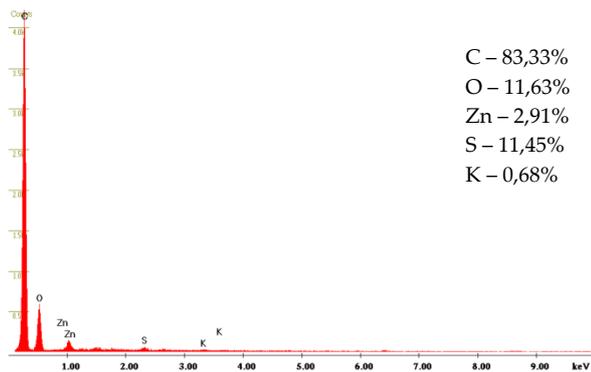
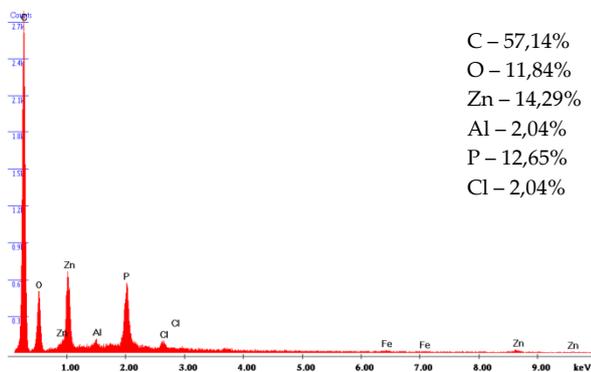
Figure 11. Analyses of different areas containing C from the cable 1.

Figures 11 and 12 show the presence of C, however, C was not always linked to phosphorus and other elements in very small amounts. As can be seen in figure 11(a), P was not detectable in the sample from area 1, however, in the remaining samples it was detected.

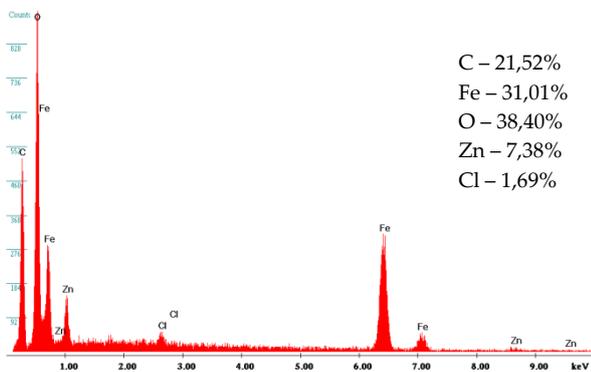
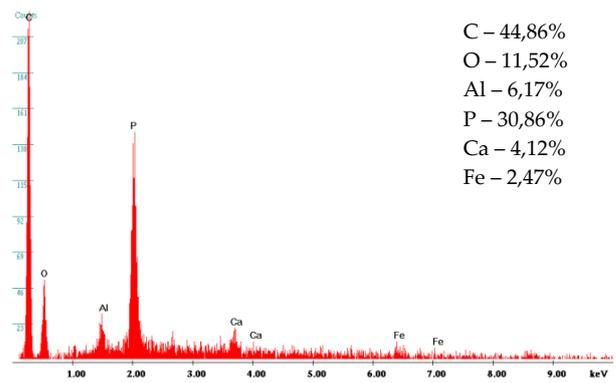
Figure 12. Analyses of different areas containing C from the cable 3.

The spectra, in figure 12, allowed to understand that there are different types of dark particles (spots) in the same area, some of them containing P and others only C or C and other small contents of other elements, such as Ca and / or Cl. In cables 1 and 3, area 1 did not have any P content, allowing to conclude that in this area it seems to be preserved from the P content. In the remaining areas they appear to contain different types of dark particles, coming from the inner polymer tube or the lubricant used during cable production.

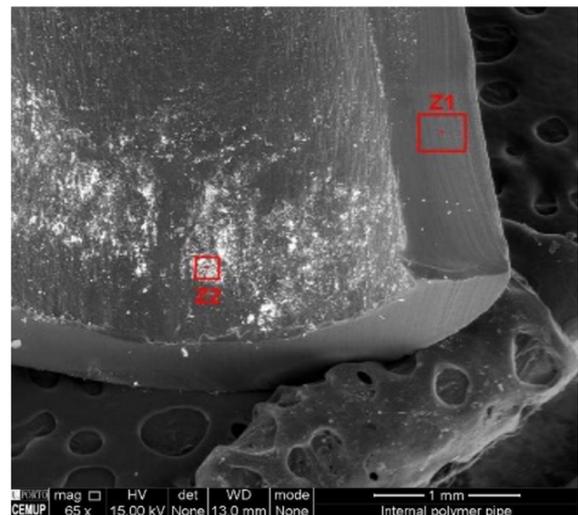
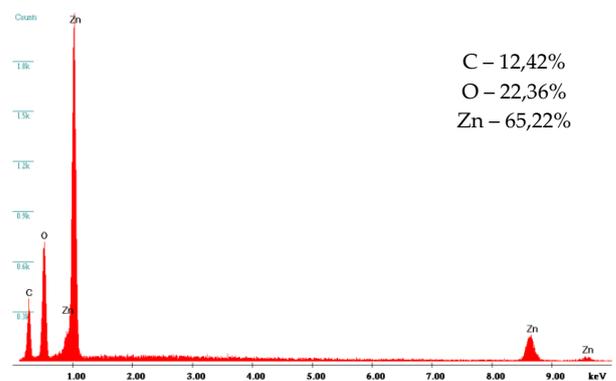
Figure 13. Internal polymer tube (a) and Micro-analysis (b).

In figure 13, it can be seen a cable sample. To verify the cable influence with the polymer tube, an analysis was made. Small particles, with a lighter colour, were detected internally. To detect the type of particles, a microanalysis was carried out to discover its composition. Most of the particles found were ZnO, the wall of the tube contained only C and the hypothesis of the polymer to contain P or other content was discarded.

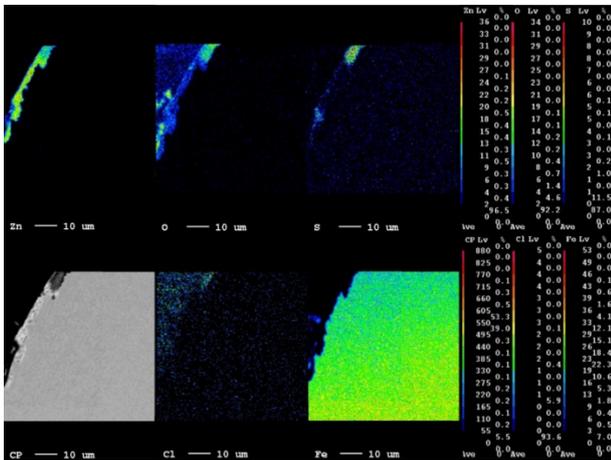
Figure 14. Spectra of the detected elements.

The use of Microanalysis by Electron Probe (EPMA) served to support the verification of possible foreign contents between the steel wire and the Zn coating, through a deep analysis of the cross-section, because any analysis made by the exterior of the wires do not allow to conclude how the ZnO is nucleated, showing evidence of its origin. Here, it was possible to obtain a generic spectrum through EPMA made to a set of samples referring to the cable area. This analysis allowed to obtain information about the elements present in the samples. As can be seen in figure 14, it is possible to state that Zn and O are almost always together, although when the intensity of O is more pronounced than that of Zn. It was also found that the presence of S was notorious, and its presence was clearly related to the incidence of O. Although the presence of Cl is quite reduced and dispersed at the coating/substrate interface, this amount should not be negligible. Cl has clear influence on the formation of ZnO [27].

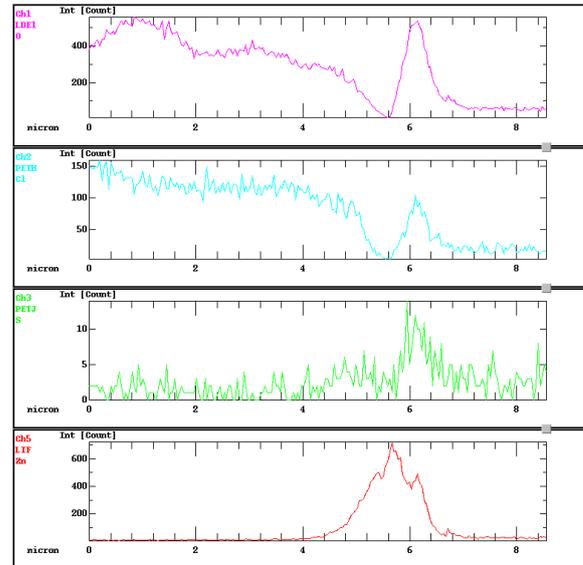
The results can be seen in figure 16, where four channels were used in order to divide the intensity and location of each element present along the line, considering that the left side of the images is the external resin and the right side the substrate of steel. Each channel was linked to a specific element: pink to O, cyan to Cl, green to S and red to Zn. Cl and O were present in the external resin (assembly process). After that, Zn became visible (coating layer) and S, Cl and O were again visible at the interface between coating and substrate. This ensures that, under the coating, there were harmful products capable of triggering the ZnO formation.

Figure 16. EPMA analyses, following a line from the outer resin to the steel substrate of figure 15.

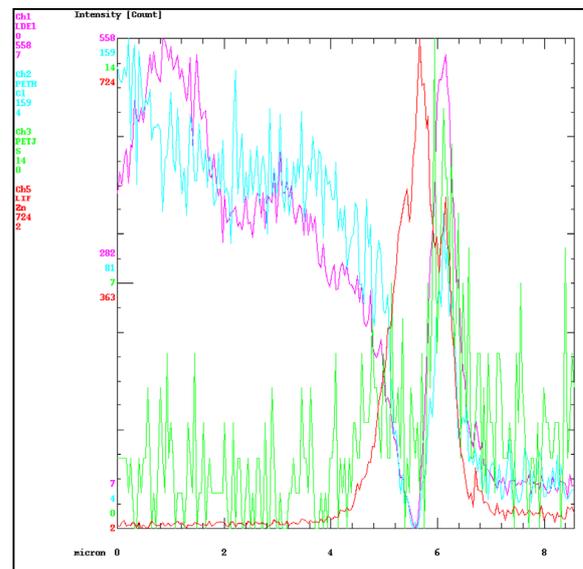
The spectrum presented below (figure 17) makes it possible to clearly analyse the phenomenon described above. The highest peak of the green line (Sulphur) is to the right of the red peak, corresponding to the Zn coating, meaning that the Sulphur is present between the coating and the steel substrate, which leads to the perception that it is present on the surface of the wire steel, that is, before the Zn coating process.

Figure 17. EPMA analysis following a line from the outside to the steel substrate - composite spectrum.
