# Corrosion-provoked Collapse of the Inclined Belt Conveyor Bridge

*This paper presents the results of the holistic failure-based root cause analysis of a sudden collapse of the inclined belt conveyor bridge (IBCB), which is a vital subsystem of a steel mill raw material handling system. Through a comprehensive analysis of the set of possible causes ('design-in' defects, 'manufacturing-in' defects, 'exploitation-in' defects and 'environmental-in' defects), by the method of elimination it has been determined that the inadequate maintenance of the anti-corrosion coating was the root cause of collapse of the IBCB. Due to inadequate maintenance of the anti-corrosion coating of the IBCB structure, heavy and uniform corrosion, provoked by increased acidity of precipitations in the area of the steel mill, had led to disintegration of structural elements and, ultimately, collapse of the IBCB structure. Additionally, based on the appearance and position of the collapsed remains of the IBCB, as well as state of the objects connected by it before the breakdown, the structural collapse scenario was established. Results of the presented investigation underline the importance of the corrosion i

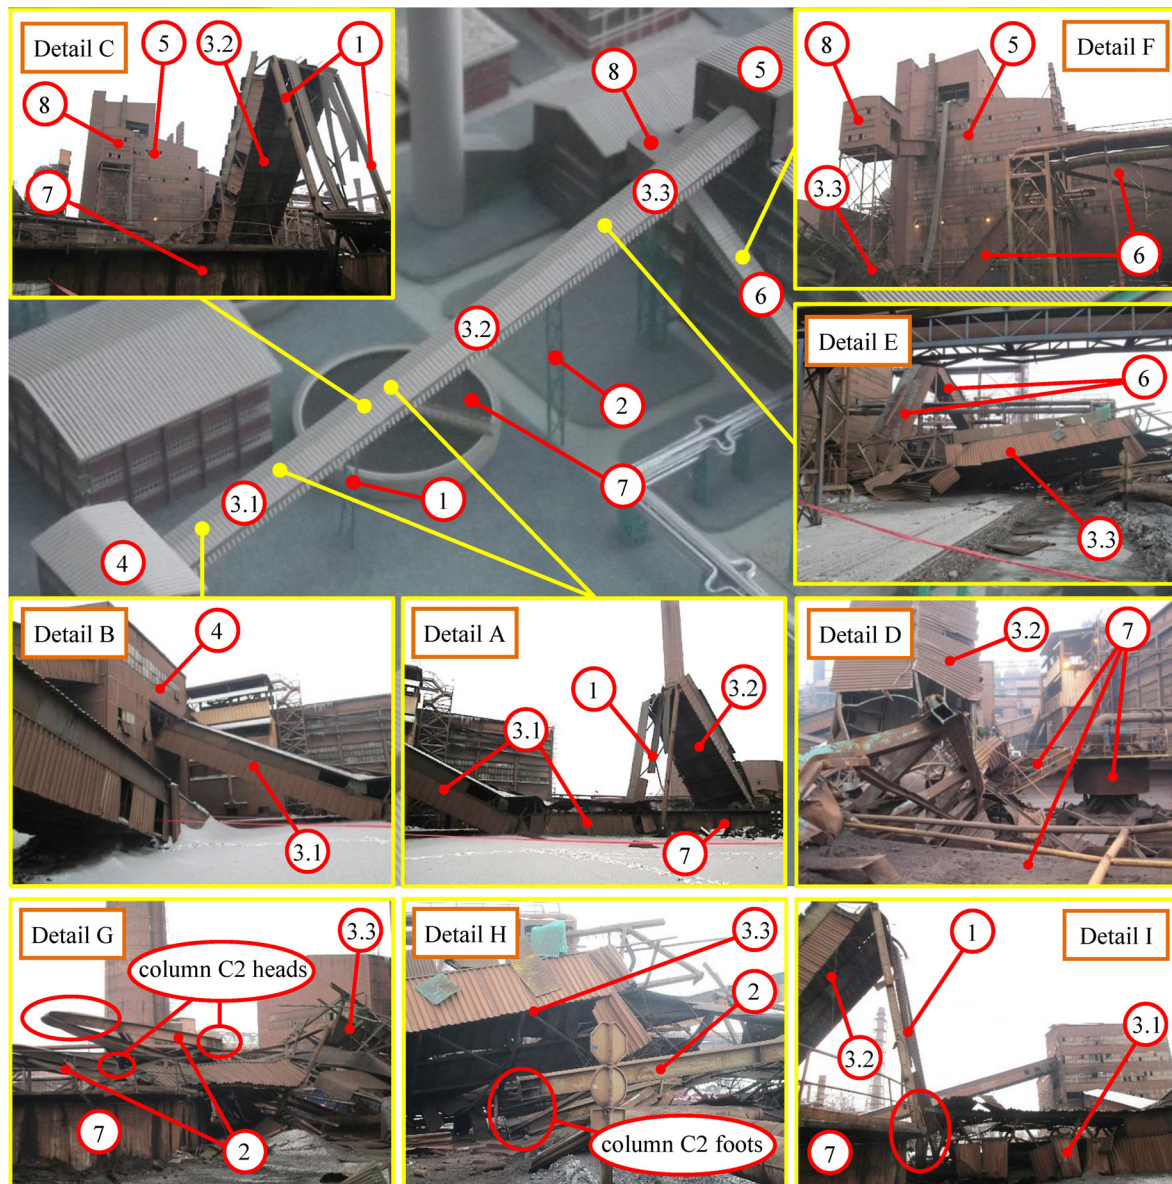
Following the sudden breakdown of the structure of the IBCB, Fig. 1 (Details A–I), thorough investigations were conducted with the goal of determining the cause of the complete collapse. This paper presents the results of: (i) visual examinations (both, in situ and in laboratory) of the collapsed structure; (ii) experimental investigations conducted on the samples taken from the representative structural elements (chemical analyses, tensile and impact tests, microhardness, as well as metallographic examinations); (iii) analysis of the referent working regimes of the BCs; (iv) analysis of the meteorological and seismic data; (v) analysis of the project documentation and the control (periodic) geodetic recordings of the construction during exploitation. By the means of a comprehensive analysis of the set of possible causes ('design-in' defects, 'manufacturing-in' defects, 'exploitation-in' defects and 'environmental-in' defects) and a method of elimination, the root cause of collapse of the IBCB was determined. Additionally, based on the appearance and position of the broken remains of the IBCB structure, as well as the conditions of the objects (facilities) it was connecting prior to the accident, the structural collapse scenario was established. Based on the analysis of the results of the invest-

**Figure 1. Layout of the inclined belt conveyor bridge and its state after the collapse: 1-column C1; 2-column C2; 3-three-segment belt conveyor bridge (segments 3.1, 3.2 and 3.3); 4-primary ore mixing plant, where the transfer point 4 is located; 5-agglomeration plant; 6-inclined belt conveyor R5-1 bridge; 7-radial precipitator; 8-transfer point 5.**

The first visual examination was conducted immediately after the accident. It was then determined that the segment 3.1 of the IBCB was fractured during the breakdown, Fig. 1 (Detail A), whereas its starting segment had remained connected to the primary ore mixing plant, Fig. 1 (Detail B). Part of the segment 3.2 which was continuing from the segment 3.1, remained connected to the column C1, Fig. 1 (Detail C), whereas the remainder of the segment 3.2 broke off and was in the radial precipitator afterwards, Fig. 1 (Detail D), as was the column C2 (Detail G). During the fall, Fig. 1 (Detail E), the segment 3.3 of the IBCB had collided with the

inclined belt conveyor R5-1 bridge, which had caused the collapse of its segment between the support column and the transfer point 5, Fig. 1 (Detail F).

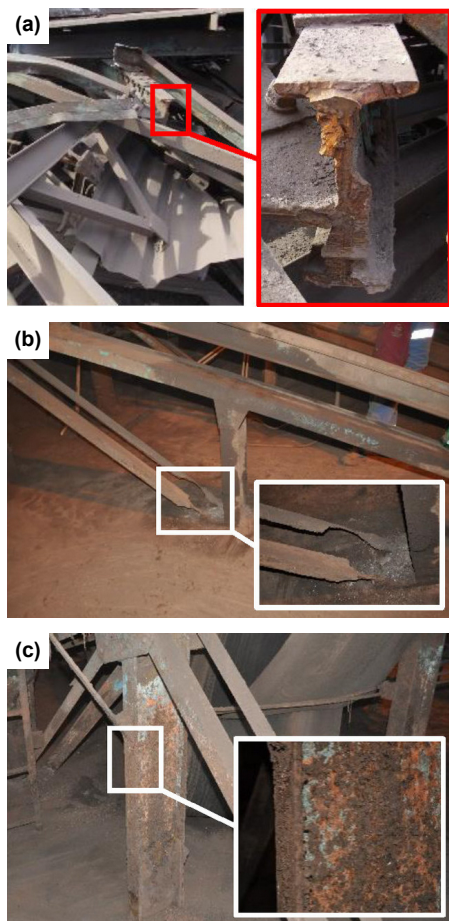
**Figure 2.** Details of the fractured element of the lower truss of the ICB structure (a), diagonal segment (b) and the column (c) of the load bearing structure of the belt conveyor drive station at the transfer point 4.

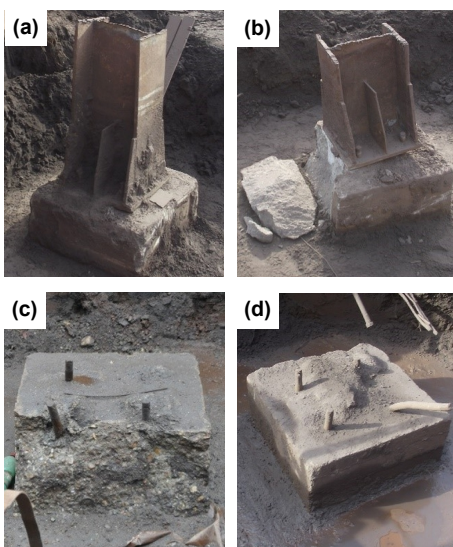
**Figure 3.** The left (a) and right (b) foundations and foots of the column C1; the left (c) and right (d) foundations of the column C2.

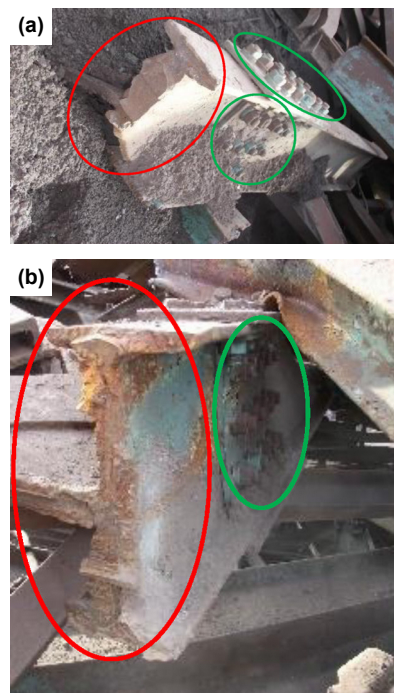
After the site of the accident was cleared, the second visual examination of the remnants of the collapsed IBCB structure was conducted. On this occasion, heavy corrosion was observed on all elements, accompanied by the complete disintegration of the structural parts, Fig. 2. The visual examination did not find any signs of settling of the concrete foundations of the columns, Fig. 3, nor a pronounced corrosion of the anchor bolts and, instead, the parts of the foundations broke off during the breakdown, Fig. 3 (b,c). Unlike the very pronounced corrosion of the structural elements, classified as C5-I [23], no high corrosion damage of the bolted joints was found on the available segments of the broken load bearing structure, Fig. 4.

**Figure 4.** Local corrosion intensity - bolted joints vs structural elements: (a) hot rolled IPN 240 beam of the lower truss; (b) hot rolled IPN 160 beam of the upper truss.

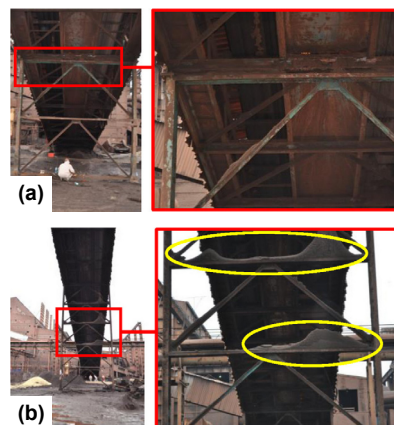
High corrosion intensity, Fig. 5(a), as well as heavy deposits of agglomerate, Fig. 5(b), were observed on the load bearing structure of a ICB located in close proximity to the collapsed ICB.

**Figure 5.** (a) High corrosion intensity of the load bearing structure of the neighboring ICB; (b) heavy deposits of agglomerate.

(also the defect of the type D3.2), observed on the structure of the neighboring IBCB (Section 2), intensify the destruction effect of corrosion and induce increased loading of the structural elements.

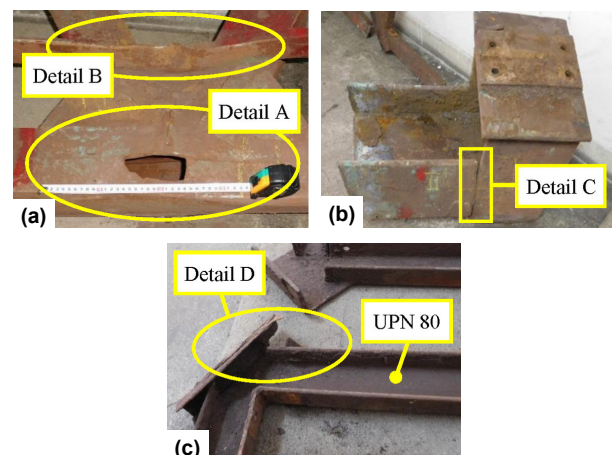
The representative structural parts selected for the laboratory visual examinations and characterization of materials used in manufacturing of the collapsed ICB structure are shown in Fig. 6.

**Figure 6.** Representative structural parts of the collapsed ICB: (a) a part of the box section of the lower truss, made from two rolled channels UPN 160 (Detail A) and a hot rolled angle L 65x65x7 (Detail B); (b) a part of the structure of the column C1; (c) a part of the girder made from hot rolled channel UPN 80.

Before the samples were taken for the experimental investigations of the material, a visual inspection was performed on the parts of the structure obtained for the tests. Apart from plastic deformation of the box section girder (2×UPN 160 hot rolled channel) of the lower truss, Fig. 6(a) (Detail A), and the hot rolled angle L 65×65×7, Fig. 6(a) (Detail B), a fracture of a part of the flange of the UPN 160 channel and the single butt weld cracking, Fig. 7(a), as well as incomplete root penetration of the said weld, Fig. 7(b), were also observed. In case of column C1, welding defects of the type incomplete root penetration and cracks, Fig. 8(a), as well as welding undercuts, Fig. 8(b), were also detected. Additionally, a very intensive and uniform corrosion was observed, which had led to the total local disintegration of certain structural elements, Fig. 6(c) (Detail D).

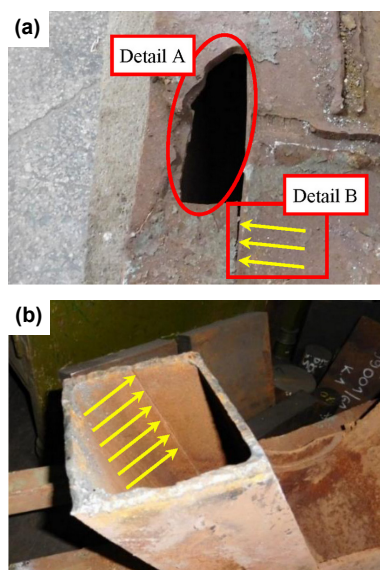
Figure 7. Details of the box girder (2×UPN 160 channel) of the lower truss of the belt conveyor bridge: (a) fracture of the part of the flange and the single butt weld cracking; (b) incomplete root penetration of the single butt weld.

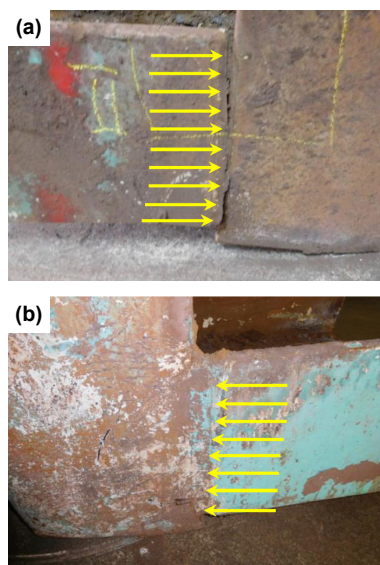
Figure 8. Welding defects of the column C1: (a) incomplete root penetration and cracks (Detail C in Fig. 6(b)); (b) undercuts.

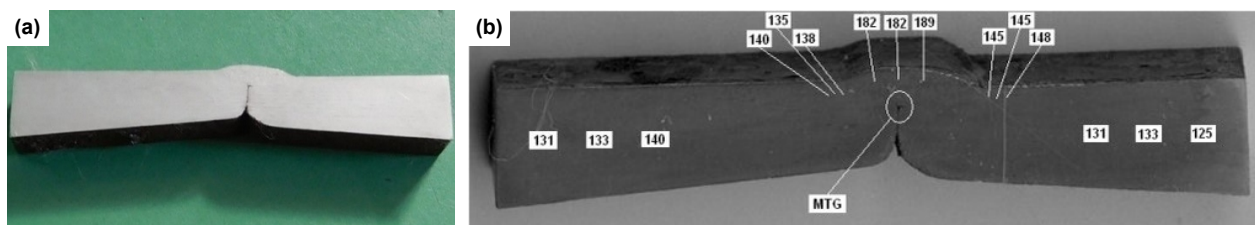
The specimen for metallography examination, Fig. 9(a), was taken from the single butt weld area of flanges of two profiles UNP 160, Fig. 7(b), where no fracturing of the welded connection had occurred. On the same specimen, microhardness (HV1) testing was also conducted, in accordance with the standard [29], Fig. 9(b). The average measured microhardness value of the parent metal is 132 HV1, Table 4, which is in compliance with the data given in [30] for quality class of steel S235J2 used to manufacture the profiles UNP 160. The average measured microhardness value in the heat-affected zone (142 HV1), as well as the average measured microhardness value of the weld metal (184 HV1) are also within the expected boundaries. If, in accordance with the expressions given in [31], the ultimate tensile stress and the yield stress values are calculated based on the value of average measured microhardness, Table 4 (parent material), the following is obtained:

Figure 9. (a) Metallographic specimen; (b) microhardness HV1 [26] and position (MTG) for metallographic examination of the single butt weld.

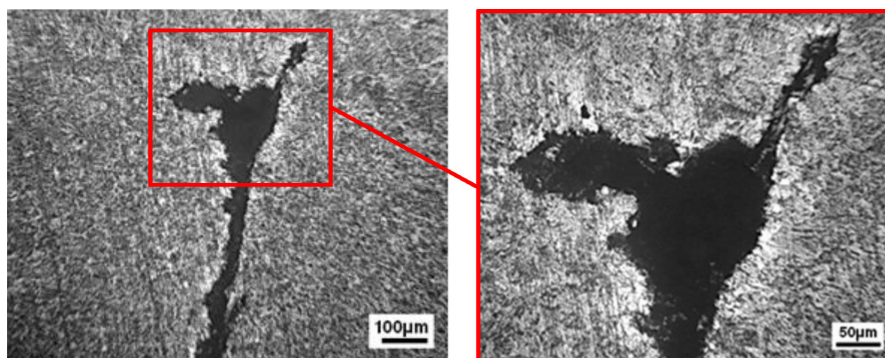
Metallographic examination of the specimen (area marked with MTG in Fig 9(b)), conducted by optical light microscope, revealed a crack in the weld metal, caused by very intensive corrosion, Fig. 10

Figure 10. Crack initiation in the weld metal.

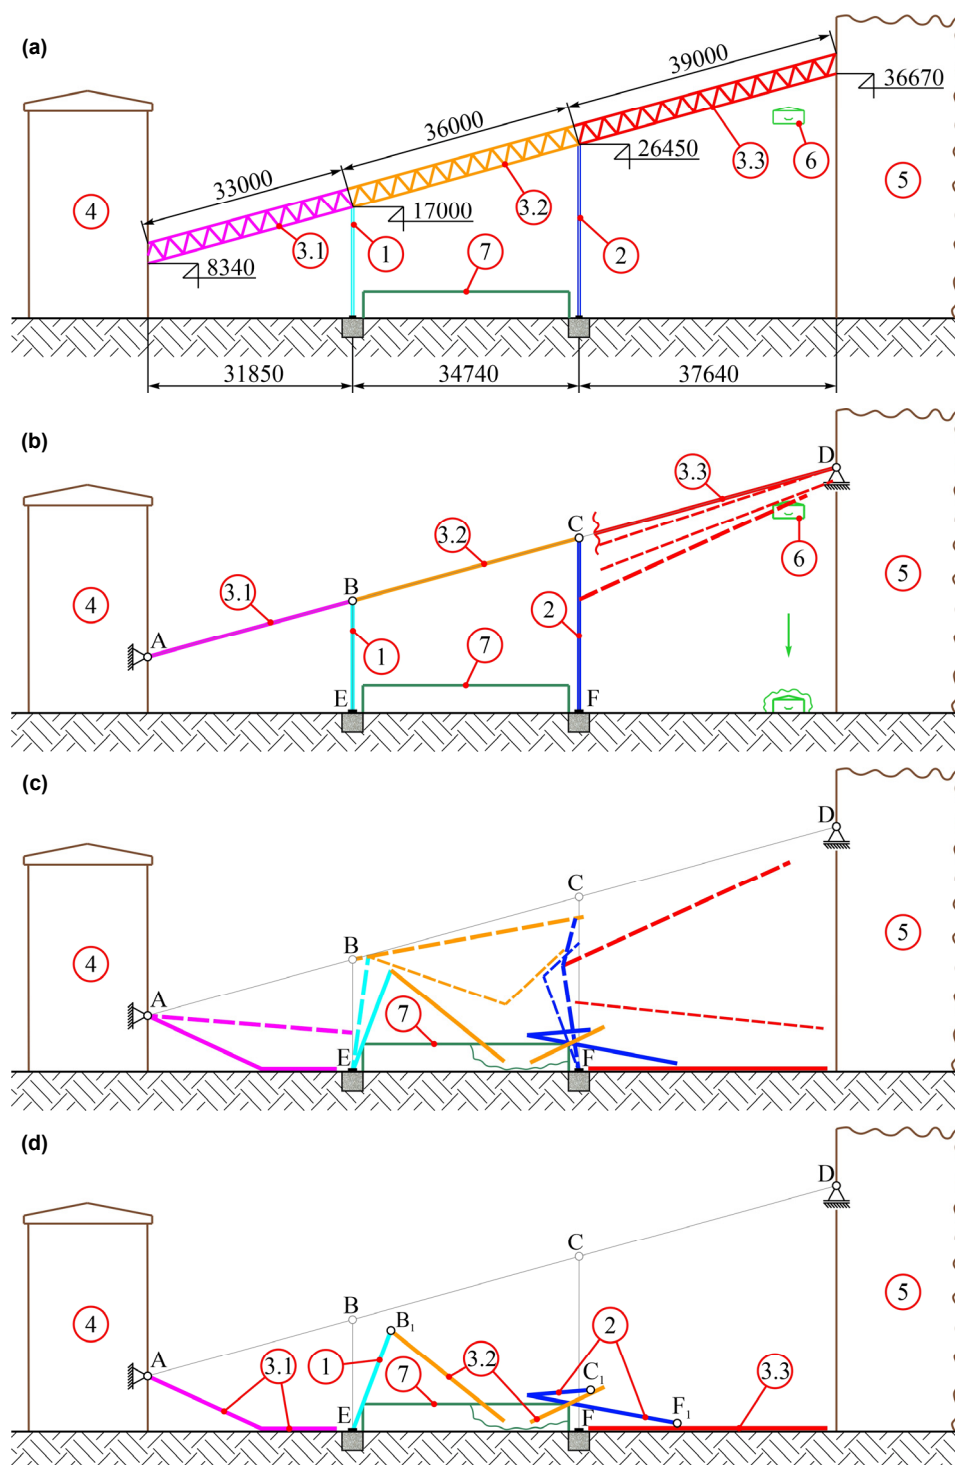
Although the collapse had occurred before noon, there were no direct witnesses nor surveillance cameras. The process of the collapse was reconstructed based on the appearance and position of the broken remains of the collapsed IBCB, the state of the object it was connecting (the primary ore mixing plant and the agglomeration plant), as well as state of the inclined belt conveyor R5-1 bridge, Figs. 1 and 11.

Based on the facts that: (i) the no damages that would point to the impact of the IBCB segment 3.3, Fig. 1 (Details C and F), were observed on the face of the agglomeration plant; (ii) after the collapse, the longitudinal direction of said segment, Fig. 1 (Detail E), corresponds to its direction before the collapse, Fig. 11(a) – direction: primary ore mixing plant (4) → agglomeration plant (5) – which means that during the collapse it was moving in practically the same vertical plane it was in before the breakdown; (iii) a segment of the inclined belt conveyor R5-1 bridge, Fig. 1 (Details E and F), which was located immediately below the IBCB segment 3.3, Figs. 1 and 11(a), had also collapsed during the breakdown; it can be concluded that the collapse of the IBCB was triggered by the corrosion-caused jeopardized integrity of the bottom chord of the segment 3.3 in close proximity of the support C, Fig. 11(b). After breaking off, the segment 3.3 had started rotating around the support D located in the agglomeration plant, Fig. 11(b), separated from it, fell and struck the inclined belt conveyor R5-1 bridge, collapsing its segment between the column and the transfer point 5, Fig. 1 (Detail E). By hitting the inclined belt conveyor R5-1 bridge, the segment 3.3 was deflected towards the column C2, Fig. 11(b). The impact of the segment 3.3 had caused plastic deformation of the column C2 and shearing of the screw connection in the support C, Fig. 11(c), whereas segment 3.3 was deflected towards the agglomeration plant and fell to the ground, between the plant and the radial precipitator, Fig. 1 (Detail E). The weight of the segment 3.2 had caused further bending of the column C2, which was accompanied by: (i) leaning of the column C2 onto the concrete construction of the radial precipitator and its total bending plastification, Fig. 1 (Detail G), as well as column foots being torn away from the concrete foundations, Fig. 1 (Detail H); (ii) rotation of the segment 3.2 around the support B, Fig. 11(c), bending of the column C1 until it rested on the radial precipitator, Fig. 1 (Detail I) and fracturing of the segment 3.2 into two parts. Its starting part, after falling into the radial precipitator, remained connected to the column C1, Fig. 1 (Detail C) and Fig. 11(c), whereas its ending part, which was resting on the column C2, also ended up in the radial precipitator, Fig. 1 (Detail D). At the same time, due to the bending of the column C1, the segment 3.1 had lost its right support (B), Fig. 11(c), and started rotating around the support A (fixed point of the belt conveyor bridge structure) located in the transfer point 4 building, and broke into two parts after falling onto the ground, Fig. 1 (Detail A). Its starting part remained connected to the primary ore mixing plant. The configuration of the IBCB after the collapse is shown in Fig. 11(d).

Figure 11. Layout of the inclined belt conveyor bridge (a) and the main stages of the breakdown (b,c,d): 1-column C1; 2-column C2; 3-three-segment belt-conveyor bridge (segments 3.1, 3.2 and 3.3); 4-primary ore mixing plant, where transfer point 4 is located; 5-agglomeration plant; 6-inclined belt-conveyor R5-1 bridge; 7-radial precipitator; 8-transfer point 5; A, D: end supports of the IBCB; B, C-intermediate supports of the IBCB, i.e. heads of the columns C1 and C2; B<sub>1</sub>, C<sub>1</sub>: position of the heads of the columns C1 and C2 after the collapse; E, F: feet of the columns C1 and C2; F<sub>1</sub>: position of the C2 feet after the collapse.
