Aircraft Duraluminum Wing Spar Fatigue Testing

Experimental fatigue crack growth analysis of the aircraft structural component subjected to different cycling loading has been presented. The purpose of the experimental test was to evaluate the fatigue behavior of the real aircraft spar, made in aluminum 2024-T3. In-house laboratory fatigue test installation is described in the paper. The spar-test specimen has been manufactured specifically for the cycling damage testing. Test results were obtained with most modern equipment for data acquisition. Applied loads and obtained spar fatigue results are described in detail. Conclusions have been made with reference to the previous work on the duraluminum spar fatigue testing. As it is presented in the previous work with advanced numerical methods for fatigue analysis, in this paper is given an opinion on the same. At the end, possible directions of the further experimental spar fatigue testing is given and shows us that it makes sense to make the comparison between real and numerical results only in situations where cracks behave similarly and the numbers of required cycles are about the same.

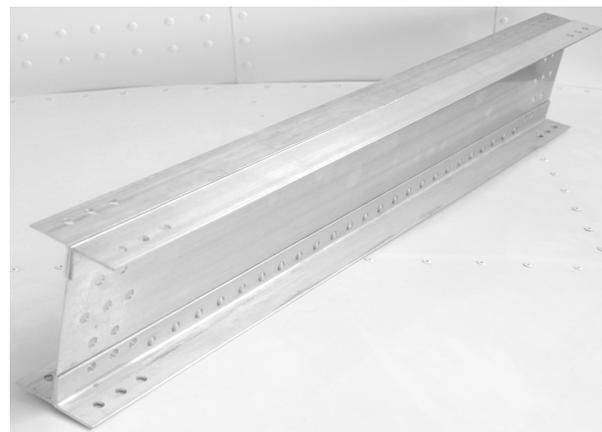
Figure 1. Aluminum spar

the chemical composition of the material. The test specimen is full scale and a geometrical representative of a light aircraft spar, Fig. 1.

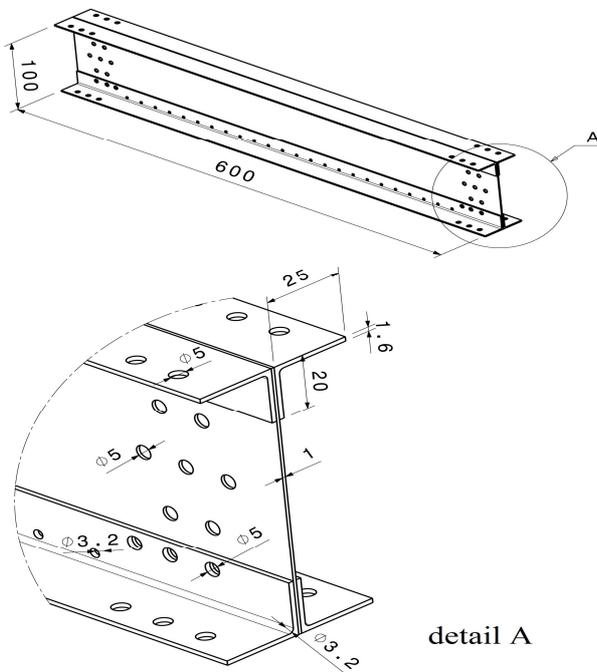
The test specimen, elementary part of the wing main spar, with its common and basic dimensions (Fig. 2) has been manufactured specially for the cycling damage testing.

Figure 2. Spar model

Spar caps and the spar wall were connected with rivets also made of aluminum alloy 2024-T3 [2]. To ensure maximum homogeneity of the spar structure, rivets were placed at the distance of 25 mm, detail A (Fig. 2).

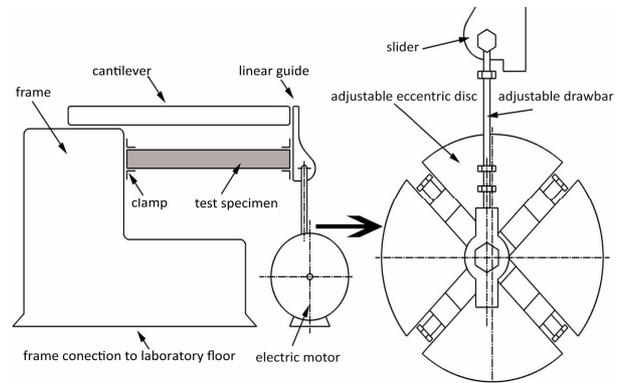
As it is shown in the Figure 3 one side of the spar was clamped with the test installation frame. On the other side, the spar was connected with an adjustable drawbar that was also connected with an adjustable eccentric disc.

The main advantages of the adjustable eccentric disc are 4 independent clamping jaws, which enable displacement in different directions. To prevent undesired torsion, and ensure only bending of the spar end, the spar was also attached with 4-bearing slider [8].

Figure 3. Test rig scheme

- Robust cast supporting frame connected to the laboratory floor. The reason for using cast iron frame is big mass and rigidity, which disable the cause of possible vibration during testing.
- Robust dovetail slider cantilever. It enables us to set different console length for different test specimens.
- Clamp with a large number of holes for connecting different test specimens.
- Linear guide connected to dovetail slider cantilever enables transversal movement.
- 4 kW electromotor, with the rotation speed of 750 rpm, also connected to the laboratory floor.
- Adjustable eccentric disc with 4 independent clamping jaws, which enables setting of the amplitudes and directions of the applied displacement.
- Rigid adjustable drawbar that enables fine displacement adjustments.
- 4-bearing slider which ensures only bending of the spar end (Item 1 in Fig. 5).

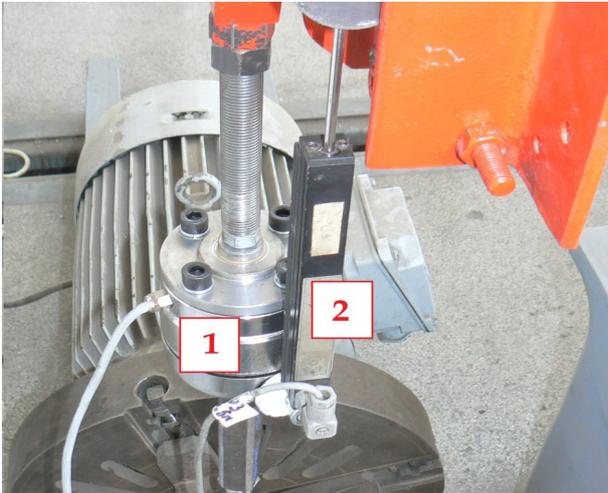
- Hottinger Baldwin Messtechnik U3 50 kN force transducer (Item 1 in Fig. 4), directly connected to the adjustable drawbar in order to obtain the best feedback about the applied force.
- ELAP PMS2S 150 mm linear displacement transducer (Item 2 in Fig. 4) was used for measuring deflection in relation to a central point.
- Hottinger Baldwin Messtechnik B12 accelerometer which was used for measuring acceleration of the slider (Item 2 in Fig. 5)

Figure 4. Force and displacement transducers

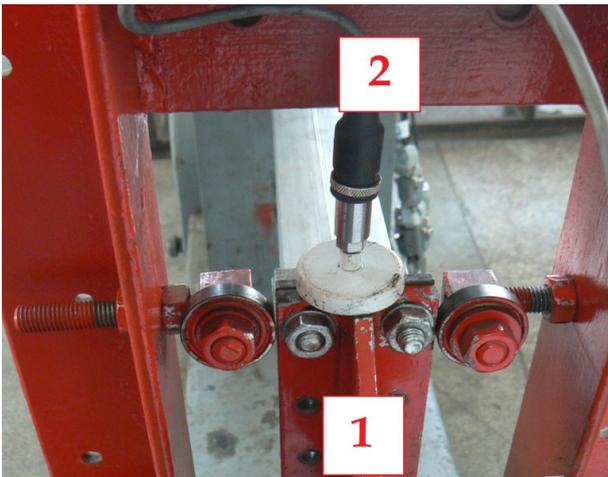
Figure 5. 4-bearing slider with mounted accelerometer

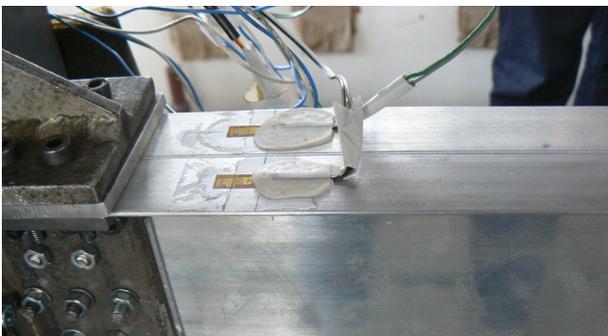
- Aluminum strain gauges HBM 1-LY13-10/120 types were used for stress measuring in the spar clamp zone at four measuring points. Each strain gauge (Fig. 6) was also connected to a dummy strain gauge into one half of the Wheatstone bridge, and then to the acquisition system.
- Data recording and some simple analyses were performed using HBM SPIDER8 acquisition system and Catman Express software package.

Figure 6. Strain gauges

Strain gages were applied at four measuring points, which are expected to be critical for the analysis [10]. They were placed on the both spar caps 20 mm from the clamp zone. At the numerical model can be seen that

Entering the zone between the vertical and horizontal spar wall there was a small difference in the "behavior" of the virtual and the real crack [13], which is explained by assuming the existence of residual tensile stresses and/or micro-damage of materials (Fig. 6 and 17).

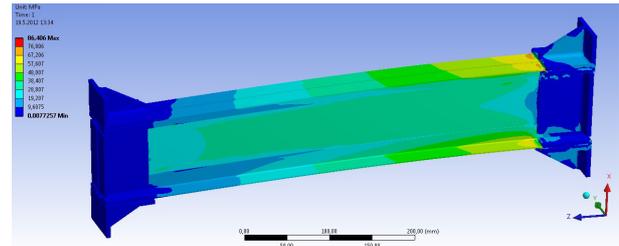
this zone, is the zone with the highest normal stresses, Fig. 7.

Figure 7. Normal stresses distribution

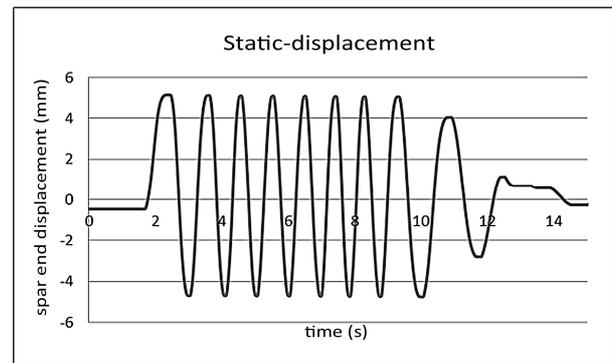
In the first phase of the experiment, static values of the force and displacement at the end of the test spar were measured (Fig. 8 and 9).

Figure 8. Static- displacement

From these two diagrams it can be seen that the narrow band sequence load has been added. The total amplitude of the displacement was 9 mm, which is significantly higher value compared to previous tests. For this value of the displacement forces ranged from -1.5 to +1.5 kN.

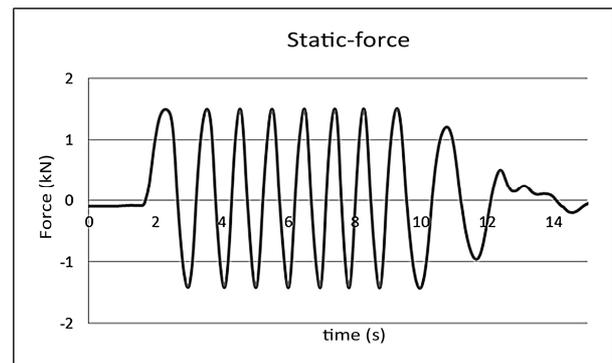
Figure 9. Static-force

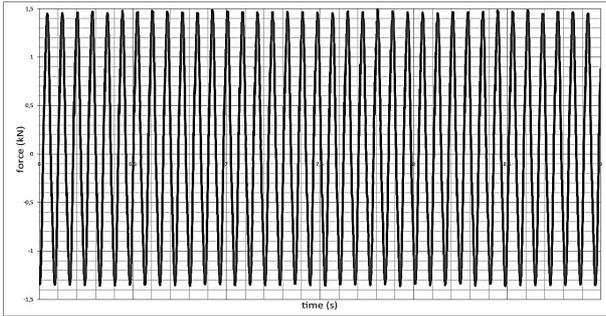
After the static measurement was carried out, dynamic force was measured at the frequency of 12.5 Hz. Fig. 10 shows the applied loads, with small insignificant changes from the static image.

Figure 10. Force vs. time - dynamics

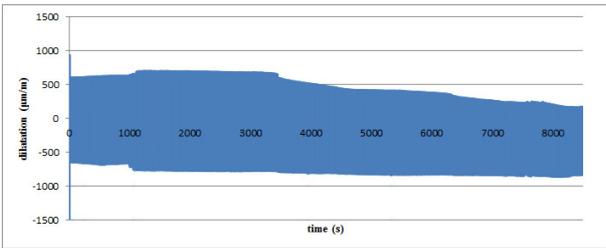
At the upper right spar cap measuring zone, shown in Fig. 11., micro crack first appeared which can be seen on the dilatation vs. time diagram, in the upper part of the right spar cap zone after 3500 seconds (43 750 cycles). After cracking, it spread for the next 6500 (81250 cycles) seconds until the termination of the experiment, when it was obvious that there exists a fracture. Based on the number of cycles until fracture we can conclude that is in the elastic plastic range and low cyclical fatigue. Also, the diagram shows that the micro dilatation at the lower spar cap zone kept constant shape which indicates that right spar cap retained the ability to carry loads.

Figure 11. Dilatation vs. time measured at the upper right spar cap zone

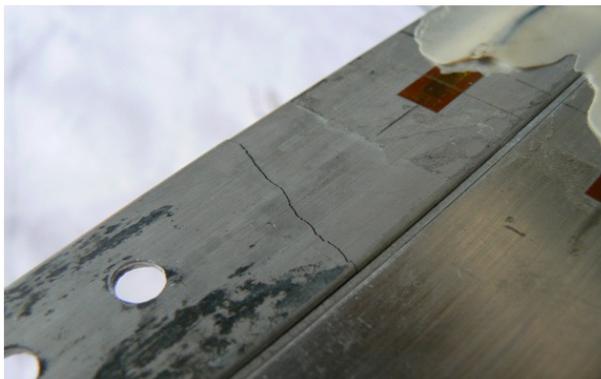
Fig. 12. shows crack at the right upper spar cap zone.

Figure 12. The crack at the upper right spar cap zone

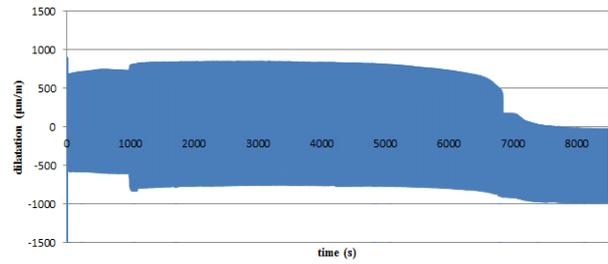
At the lower left spar cap measuring zone, shown in Fig. 13., micro crack also appeared in the upper part of the left spar cap zone after 5000 seconds (62 500 cycles). Brittle fracture of materials can be observed after 6800 seconds (85 000 cycles). Cause of micro dilatation increase in the lower part zone is load transfer on the spar wall.

Figure 13. Dilatation vs. time measured at the lower left spar cap zone

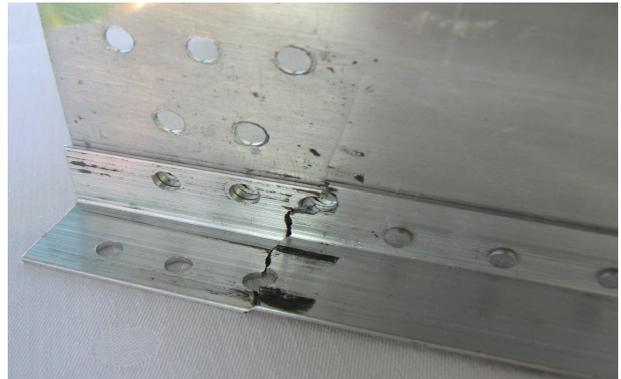
Fig. 14. shows crack at the left lower spar cap zone.

Figure 14. The crack at the left lower spar cap zone

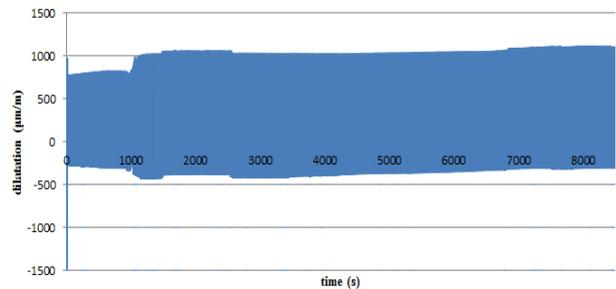
At the lower right spar cap measuring zone shown in Fig. 15. micro crack appeared in the lower part of the left spar cap zone after 3000 seconds (37 500 cycles). At the upper zone there has been a slight increase of the micro dilatation, also due to the load transfer trough the spar wall.

Figure 15. Dilatation vs. time measured at the right lower spar cap zone

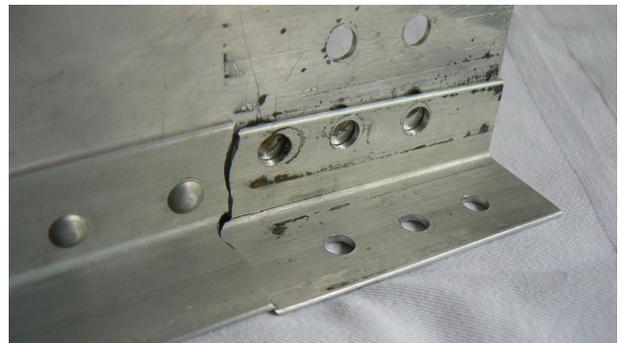
Fig. 16. shows crack at the right lower spar cap zone.

Figure 16. The crack at the right lower spar cap zone

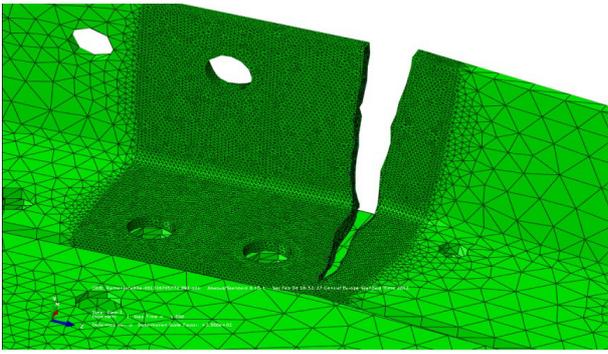
Figure 17. Virtual crack path

In previous spar fatigue works this type of crack propagation never appeared. However these results coincided with the numerical crack propagation model [10], [11], [12] developed in the previous spar fatigue work, Fig. 17.

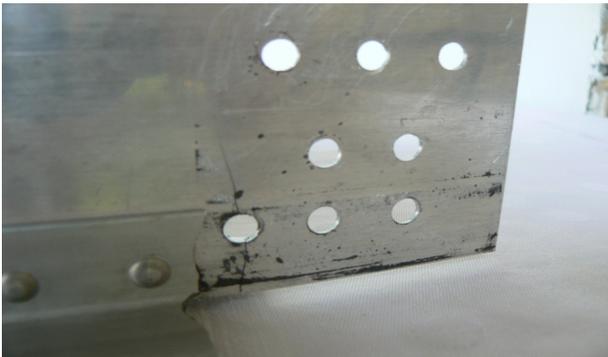
After the experiment termination, we have seen that the crack that could not be seen during experiment started to spread to spar wall. Wall crack is shown in the Fig. 18.

Figure 18. Wall crack path
