Characterization of Solid Residues Emerging During Ultrasonic Cleaning Treatments of Tyre Moulds

The present paper aims at the investigation of the nature and possible origin of solid residues found in the washing basins of Ultrasonic Mould Cleaning System (UMCS) plants. In particular, analyses have been focused on the potential PTFE provenience of the debris and the eventual effect of acid solutions used in the process. Moreover, spring vents taken apart from tyre moulds subjected to repeated use and cleaning cycles, have been analysed in order to determine signs of wear, damage extent and its possible causes. Analyses have been performed by means of FT-IR, TGA, SEM-EDX and XRF, obtaining information on both organic and inorganic fractions. Results obtained seem to indicate that the degradation of PTFE is not responsible of the presence of these debris, and the acid solutions used in the process appear not to have a significant or direct role in the degradation and oxidation patterns.

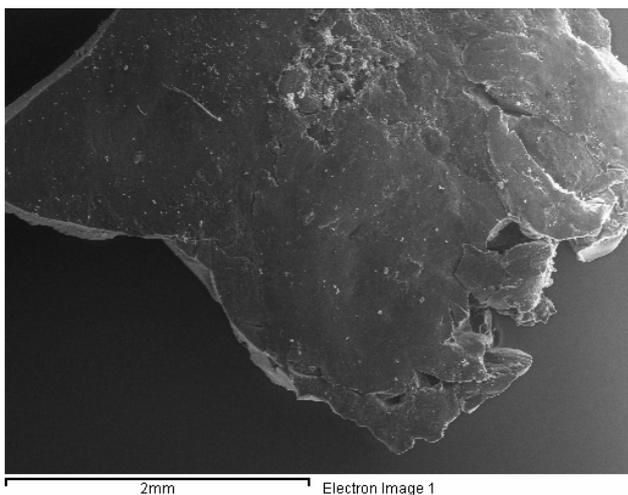
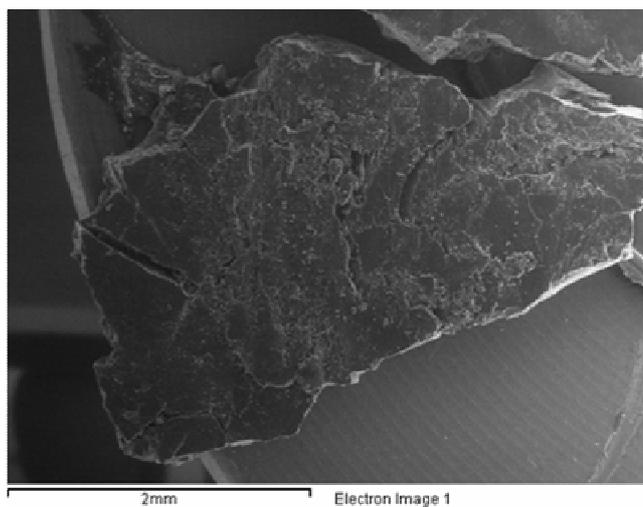
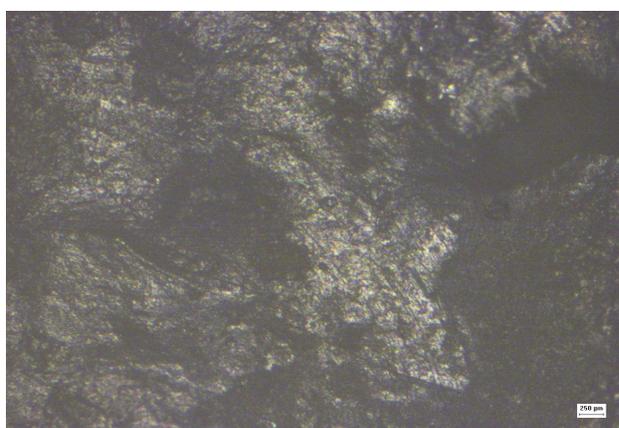
Figure 2: Different micrographs of particles named A with rough, uneven and darker surfaces. SEM (top), confocal microscope (centre) and Spotlight 200 FT-IR microscope (bottom)

The visual inspection, performed with both Zeiss confocal microscope and Spotlight 200, of the different samples of solid residues shows two different morphologies, named A and B, as can be seen by the series of images reported in Figure 2 for the sample A and Figure 3 for the sample B.

The two different morphologies have been recognized due to difference of the surfaces, in terms of colour and aspects: rough, uneven, less thick and dark coloured the first (A); more smooth, plain, compact and light coloured the latter (B). In order to determine eventual compositional differences between the two

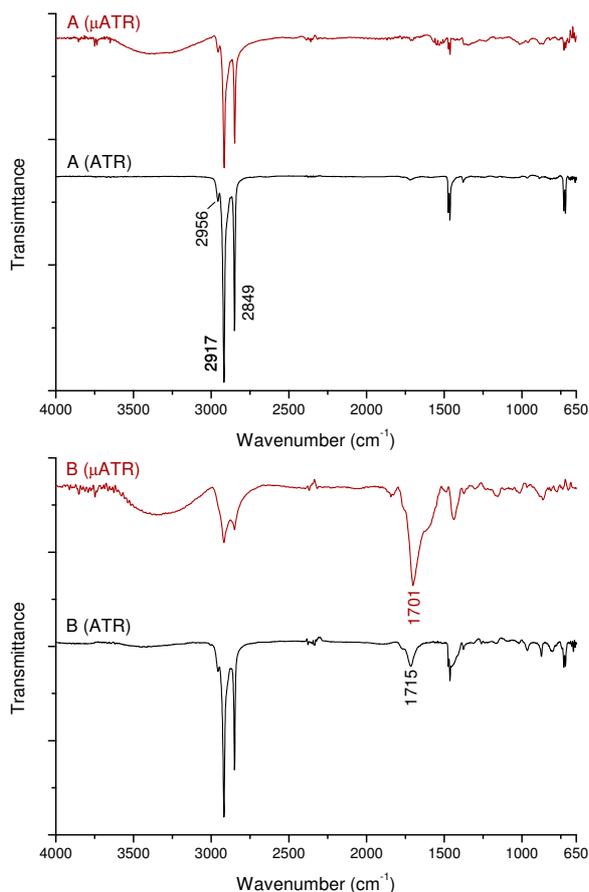
Figure 4: ATR/ μ ATR spectra of the two samples of solid residue (A, top; B, bottom)

In Figure 4 are reported the FT-IR spectra (ATR and μ ATR) of the samples A and B.

The comparison of the spectra reported in Figure 4 seems to indicate that the chemical nature of the two morphologies identified from visual inspection could be considered almost identical. In fact, both samples show major signals at 2849, 2917 and 2956 cm^{-1} . These

signals are attributable to C-H stretching absorption typical of extended aliphatic chains with unsaturated bonds, which may be ascribed to fragments of polymers like polyisoprene or polybutadiene. However, a slight difference can be seen between the two samples.

Spectra of B samples show signals at 1701 and 1710 cm^{-1} , that are possibly attributable to carbonyl (C=O) groups. These signals may be considered as signs of slightly higher degradation by oxidation of B samples, compared to A ones [21-23]. The complete absence of signals at about 1200 and 1148 cm^{-1} , which are related to symmetric and asymmetric stretching vibrations of CF_2 bonds [24-26], seems to exclude the presence of PTFE residue and, therefore, the Teflon provenience of these debris. This was one of the possible sources due to gaskets failure used in the same plants, as already investigated [14, 15]. Figure 5 shows the superposition of the FT-IR spectra of sample A, B and of the PTFE gaskets as well as reported in [14].

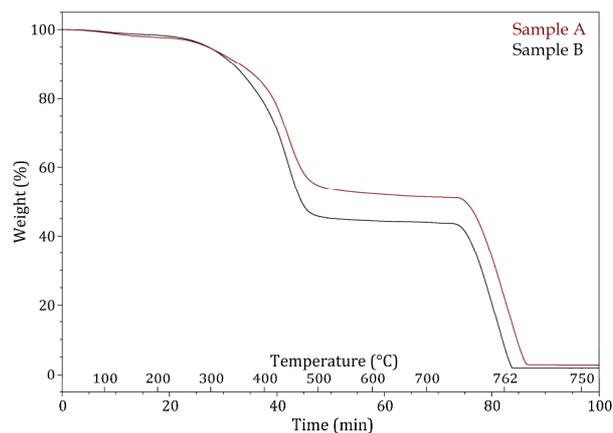
Figure 6: TGA thermograms of sample A (red) and B (black)

Samples A and B have been then subjected to thermogravimetric analysis (TGA), in order to characterize their thermal properties. Thermograms are reported in Figure 6, and results are summarized in Table 1.

From the point of view of thermal properties, it can be seen that the two sample behave in an almost identical manner. The initial minor weight losses occurring for both samples at about 100 – 110 $^{\circ}\text{C}$ were not taken into account because they have been considered to be simple humidity retained by the samples. Major differences may be found in the entity of the first weight loss (1 in Table 1), which is slightly greater and occurring at few Celsius degrees higher for sample B. This fact could possibly mean that the organic (i.e. polymeric) fraction is higher compared to Sample A.

The second weight loss (2 in Table 1) correspond to the complete oxidation of the samples, after the atmosphere switch from nitrogen to air. These losses show an opposite behaviour, with slightly higher entity of the weight loss and peak temperature for sample A, possibly suggesting a higher carbon-to-oxygen ratio compared to sample B. Moreover, sample A residue is higher than that of sample B.

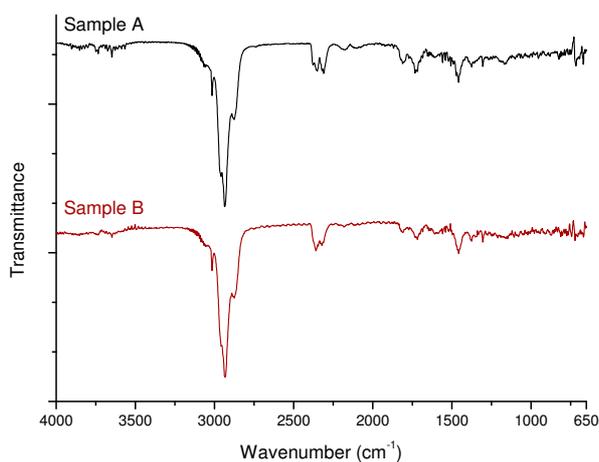
Figure 7: FT-IR spectra of the evolved gases from TGA. Sample A (top) and Sample B (bottom)

With the intention of carry out a more in depth analysis, the evolved gases arising from the TGA have been continuously sampled and analysed by FT-IR. The resultant spectra are reported in Figure 7.

It can be easily seen that the two spectra almost perfectly overlap, which may suggest that the organic component of the two samples should be the same. The comparison performed using the spectral libraries available suggest that the gases could be composed of octene or decene (aliphatic chain) as well as reported in Figure 8.

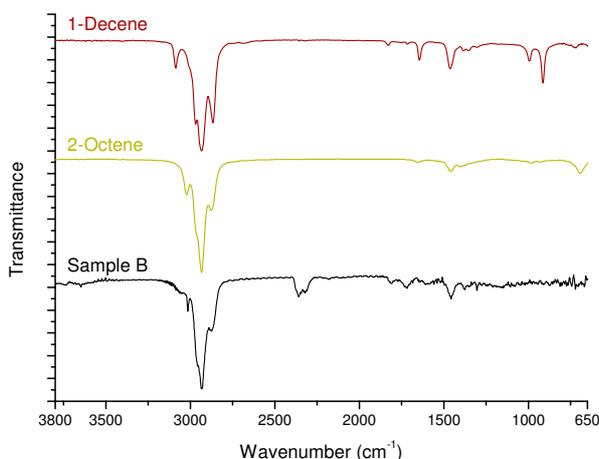
Figure 8: spectral libraries comparison between FT-IR spectra of evolved gases from B with 2-Octene/1-Decene

This result seems to indicate the presence of relatively short aliphatic fragments with unsaturated bonds, due to the thermal fragmentation of longer polyene chains, in accordance to what emerged from the ATR/ μ ATR analysis of both samples.

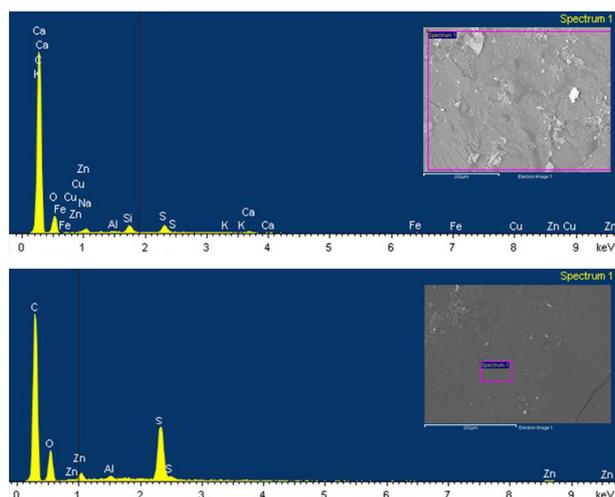
Figure 9: SEM micrographs and related EDX spectra of sample A and Sample B

Finally, elemental analysis by means of SEM-EDX, has been done in order to determine the elemental composition of the two samples and to investigate also the inorganic composition of the debris. Different

specimens for each of the two samples A and B have been analysed and for each specimen various sampling points have been chosen, in order to minimize spot errors and have the most faithful elemental composition. Moreover, large sampling areas have been subjected to scanning and automatic averaging of the data, in order to have a mean composition of the specimens, as reported in Figure 9.

The elemental composition of both samples show the presence of carbon and oxygen as the two major elements. The latter is present at higher weight percentage in sample B, in accordance with FT-IR analysis, and could allow to confirm that sample B is more oxidized than sample A. Further analysing the data allow to notice the presence of quite high quantity of sulphur and zinc. These two elements are typically present in tyre rubber formulation as vulcanization agent and accelerator, respectively [11]. However, the quantity of these elements is relevantly higher in sample B: sulphur quantity is six time higher, while zinc is the double. On the other hand, sample A is composed also by small quantities of alkali and alkaline earth metals (sodium, potassium, calcium), metalloid (silicon) and transition metals (iron and copper). While some of these elements are commonly found in tyres pyrolysis char, the percentages found in the investigated samples are significantly higher [11].

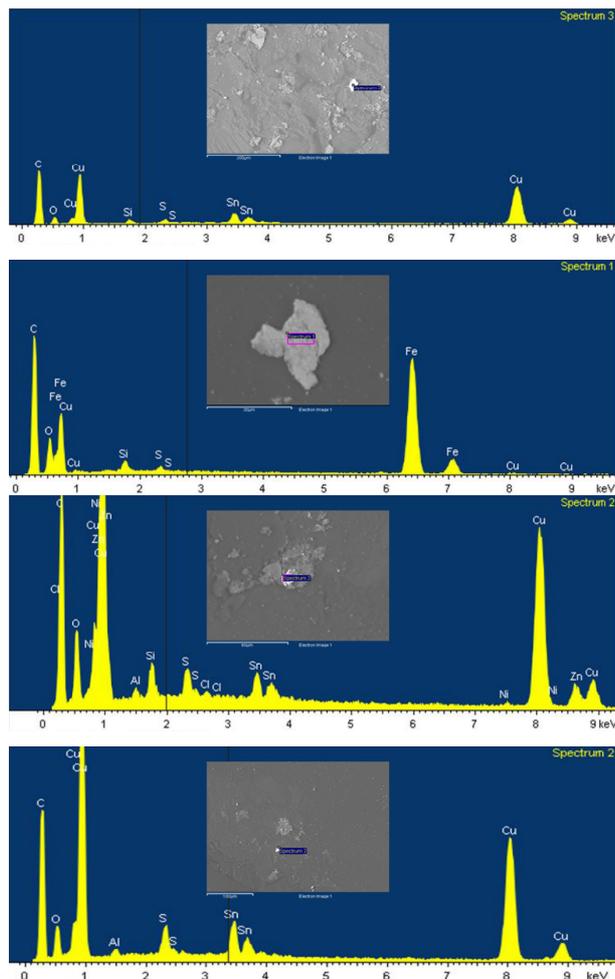
Figure 10: SEM micrographs and related EDX spectra of peculiar spots over the surfaces of sample A and Sample B. Top to bottom: A1, A2, B1, B2

Furthermore, EDX spectra of other peculiar spots of the solid residue samples have been acquired. These spots appear like micrometric particles adhering on the surface, as show in Figure 10, where the most relevant EDX spectra and corresponding micrographs of the acquired sample area are reported.

The chemical composition of these micrometric grains is reported in Table 3. It results that the most abundant elements are transition metals. In fact, a part from carbon and oxygen, both still present but clearly decreased in quantity, other major elements identified are copper and tin, with the simultaneous presence of zinc in one case (B1).

Only A2 sample contains iron. Sulphur is still present, but in a significant reduced extent when compared to A and B samples (see Table 2). However, the presence of sulphur maintains the same trend seen

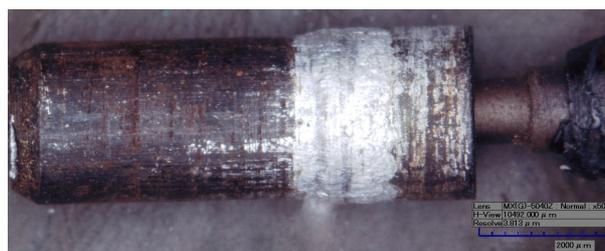
Figure 11: Hirox 7700 micrograph of the spring vent

At last, SEM-EDX analysis has been performed on some spring vents from the tyre moulds actually subjected to different cleaning cycles in the UMSC plants. Figure 11 shows a micrograph of the whole spring vent subjected to analysis. It can be seen that the surface is evidently damaged, with a consistent part covered by a dark coloured layer, and the diffused presence of reddish stains normally associated with iron oxides.

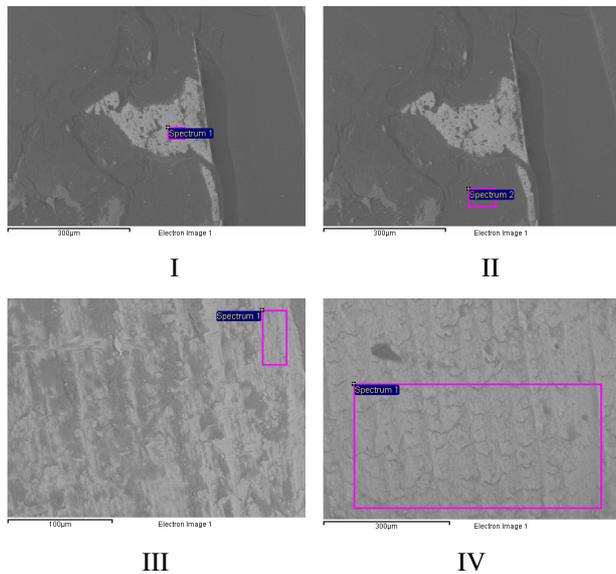
Figure 12: SEM micrographs and sampling area of the surface of a tyre mould spring vent

Figure 12 shows SEM micrographs of the more interesting sampling areas examined. Some parts of the spring vent are covered by a thin black layer (I-II), while other parts appear less damaged (III), or nearly intact (IV).

The elemental analysis corresponding to the micrographs of Figure 12 are reported in Table 5.

It seems reasonable that the black thin layer analysed in II could be related to the composition of the debris found at the bottom of the basins, thus to the possible tyre rubber composition (Table 2). In fact, it is possible to observe, besides carbon and oxygen, the presence of moderate quantities of sulphur and zinc. The metallic spot in the same frame, analysed in I still shows the presence of carbon, but the most abundant element is iron. The same is for III and IV, which show, in addition, relevant quantities of aluminium and manganese, as well as low content of silicon and chrome. These former elements are not typically found in tyre rubber compounds and are plausibly arising from treatments carried on the spring vents.
