Electromechanical Vibrations of the Vertical Lathe Machining Centre Caused by the Fault of the Working Table Rolling Bearing

In the circumstance of the commissioning of a vertical machining lathe centre, since a previous overhaul due to operative inattention, the rolling bearing of the working table was damaged. When this damaged part was changed, a detection of the machine dynamic response by vibration measurements was also performed. An unacceptable level of vibrations was detected which negatively influences the machining quality. Although it was initially suspected that the higher level of vibrations was solely due to a combination of mechanical causes, an additional analysis performed on frequencies, showing more complex vibrational spectra, suggested a deep interaction between electrical and mechanical criticalities.

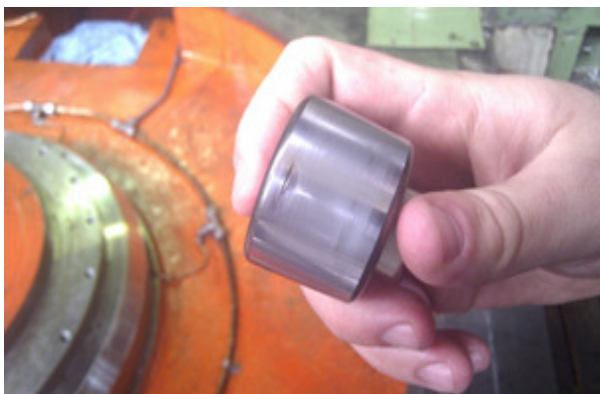
Figure 3. Mechanical damage of rolling bearing

Mathematical models to describe the contact between the rolling elements, figure 3 and sliding track as the dominant contribution for the mathematical description of the impact energy that occurs in defective bearing, taking into account the size of the defect, the geometry of the components of the bearing and speed of movement of the bearing shaft.

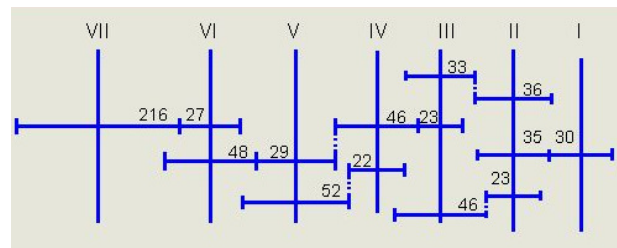
Figure 4. Schematic description of lathe machine gearbox

2.2 Mechanical vibrations caused by shafts and gearbox

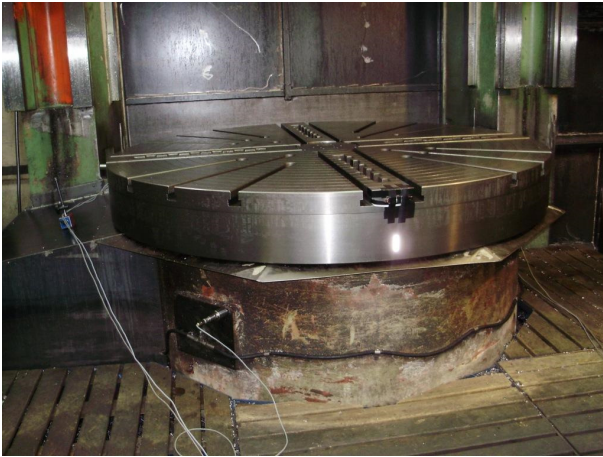
Figure 5. Working table with measuring equipment

In the process of measuring the vibration of the lathe's table the three non-contact measuring devices are used (two non-contact displacement sensor IN 085 and one optical phase sensor P-84 measuring spindle speed). The non-contact measuring sensors work on the Eddy current principle, so it is necessary to calibrate them before each measurement (the gap between the top of the sensor and lathe's table should be adjusted). The optical phase sensor work on the principle of emission of light beam and the detection of reflected beam from the reference marker which should be applied on the surface of the lathe table, Figure 5.

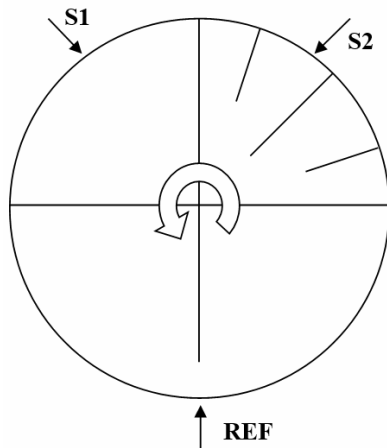
Figure 6. Position of sensors around of working table

applications within software packages LabVIEW and Matlab/Simulink. The placement of the non-contact sensors (S1 and S2) as well as optical phase sensor (REF) in relation to the lathe working table are shown in the Figure 6.

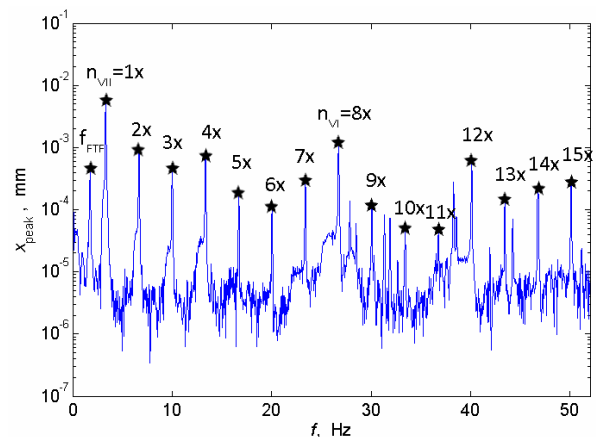
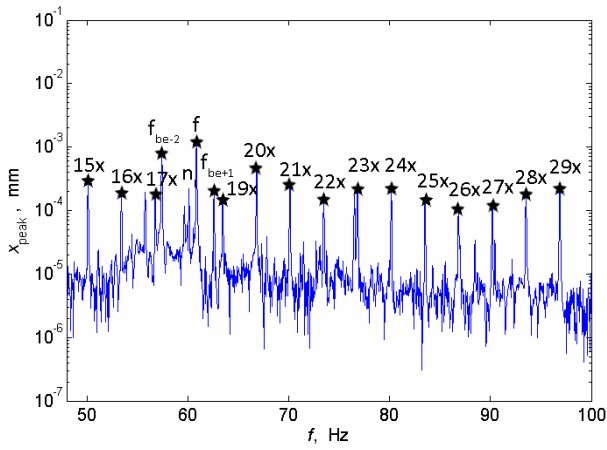
Figure 7. Displacements in frequency range 0-50 Hz

Figure 8. Displacements in frequency range 50-100 Hz

In particular, on the figures 7 and 8, the overview of the vibration frequencies content from 0 – 100 Hz is shown. The high magnitude of the bearing's f_{FTF} (Fundamental Train Frequency is visible and this frequency will be used as characteristic frequency f_{char} , connected with appearance of coupled electro – mechanical vibrations. Also the rotational frequency of the working table marked as 1x as well as its higher harmonics are show too. Mentioned frequency spectrum also contains the rotational frequencies connected with the specific unbalance of some shafts (n_{VI} and n_I) from the lathe machine gearbox.

It is also noteworthy, the mentioned frequency spectrums contain a frequencies connected with electro – mechanical vibrations (f_{BE-2} (parameter $k=-2$ in the table 2), f and f_{BE+1} (parameter $k=+1$ in the table 2)). These vibrations induced by electro – mechanical cause has very important influence on the whole level of vibrations. The reason why this frequencies has greater importance than those lower connected with the working table rotation is the fact that measurement of vibration displacement (like in this case) emphasize the content of lower frequencies.

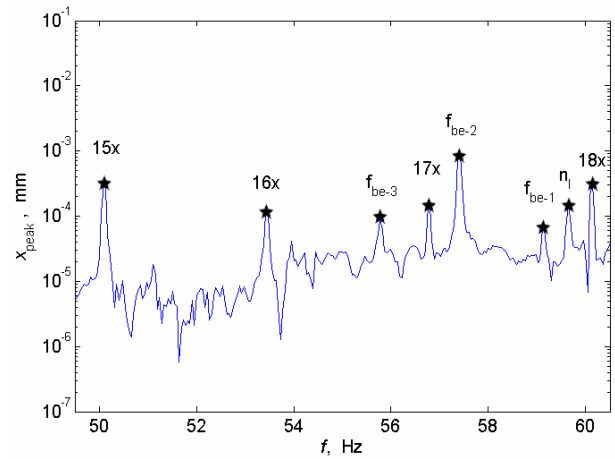
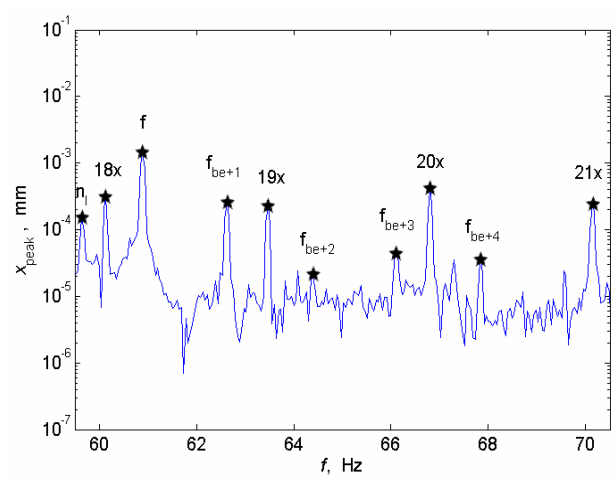
Figure 11. Displacements in frequency range 50-60 Hz

Figure 12. Displacements in frequency range 60-70 Hz

As it is mentioned before, a very important influence show the frequencies connected with electro – mechanical vibrations f_{BE-2} , f and f_{BE+1} which can be found, with significant magnitude, also on the Figures 11 and 12, showing, respectively, the frequency range of 50-60 Hz and 60-70 Hz. To further investigate this phenomenon, additional measurements is performed. Unlike previous described measurements which were performed with non – contact measuring sensors on the working table, in this

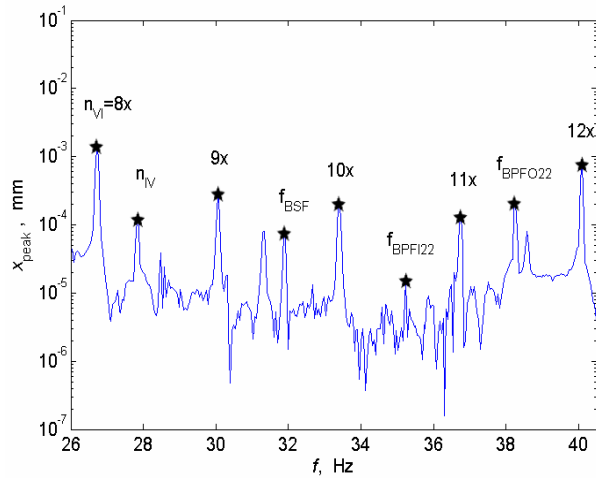
Figure 9. Displacements in frequency range 26-40 Hz

frequency measuring domain is divided to the smaller areas, Figures 9-13. On the Figure 9, showing the displacements in the frequency range of 26-40 Hz, the remaining three characteristic frequencies of roller bearing: BSF (Ball Spin Frequency), BPFO22 (Ball Pass Frequency Outer Race for 22 rolling elements) and BPFI (Ball Pass Frequency Inner Race for 22 rolling elements), are visible. These diagrams contain also the frequencies of two rotating shafts (n_{VI} and n_{IV}) as well as 9-11 harmonics of the working table rotational speed.

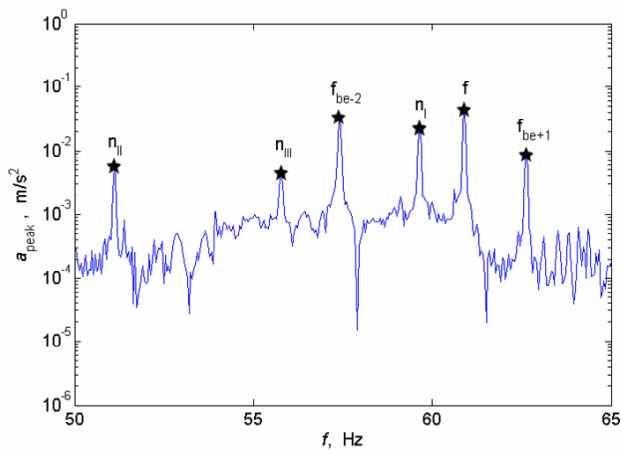
Figure 14. Accelerations in frequency range 50-65 Hz – contact measurements on foundation

case the vibration acceleration is measured on the lathe machine foundation. Two contact sensors Bruel&Kjaer AS020, positioned on foundation near the faulted working table bearing, are used in that measurement.

Measurement of the acceleration frequency spectrum between 50 and 65 Hz, which results are given on the Fig. 14 confirmed the higher frequency content connected with electro – mechanic cause of vibrations, while the rotating shafts frequencies (n_I , n_{II} and n_{III}) are also presented, but to a lesser extent. The appearance of new frequencies connected with the shaft's unbalances, which did not appear in the spectrums before, it is possible to interpret with the fact that the mechanical disturbance is transferred from the place of origin, further through the overall structure of the machine. Therefore, in some specific measuring places, individual characteristic frequencies will be more or less pronounced.
