Stress Distribution as a Cause of Industrial Steel Chimney Root Section Failure

This paper has studied failure initiation of the root section of 60 m tall industrial steel chimney. Cracks that occurred in steel wall of the wind shield have significantly influenced integrity of the structure. Analytical and numerical analysis of failure occurrence was performed. Location of extreme stress values in the steel structure were identified numerically by finite element method. Identified locations coincided with the location of the cracks initiation. The results of analysis identified causes of the failure initiation and allowed expression of the recommendation for root redesign and further maintenance procedures.

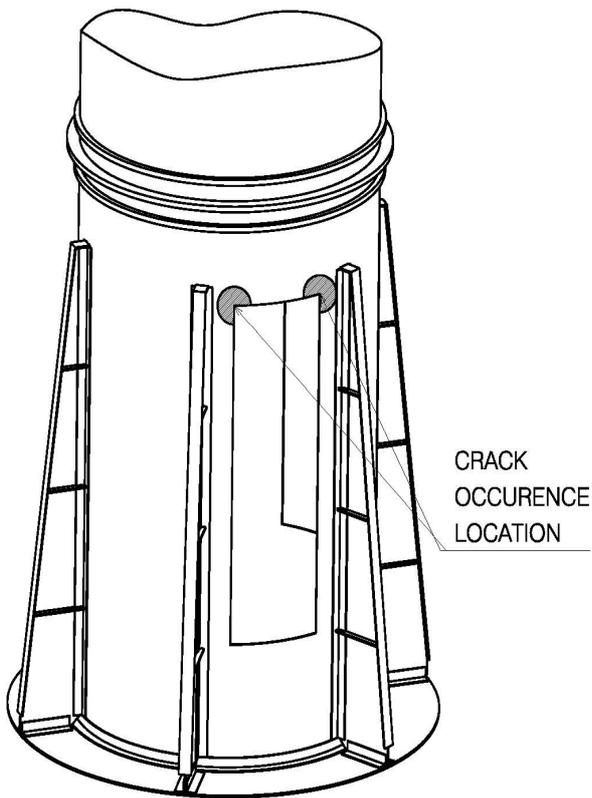
Figure 3. Chimney's root section

- A total of six cracks are initiated at root segment of chimney structure;
- All cracks are initiated on the upper corners of flue duct entries;
- Two cracks are longer than 400 mm with varying propagation direction at outer wall;
- Four cracks are shorter than 100 mm with vertical propagation direction at the outer wall.

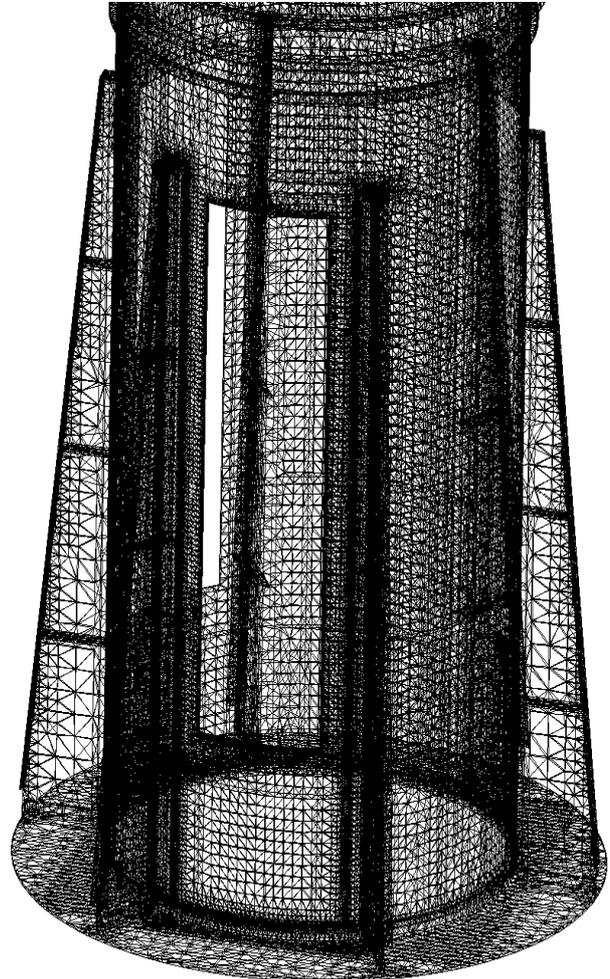
Figure 9. FEM Model of chimney's root section

3D CAD model of the structure was a starting point in creating finite element model. The model presents the continuum discretized by the 10-node parabolic tetrahedron elements [20,21] in order to create FEM model. FEM model of the chimney structure consists of 174,948 nodes. Figures 9 and 10 show details of the root section finite element model [22]. The size of the elements varies depending on the local geometry of the structure.

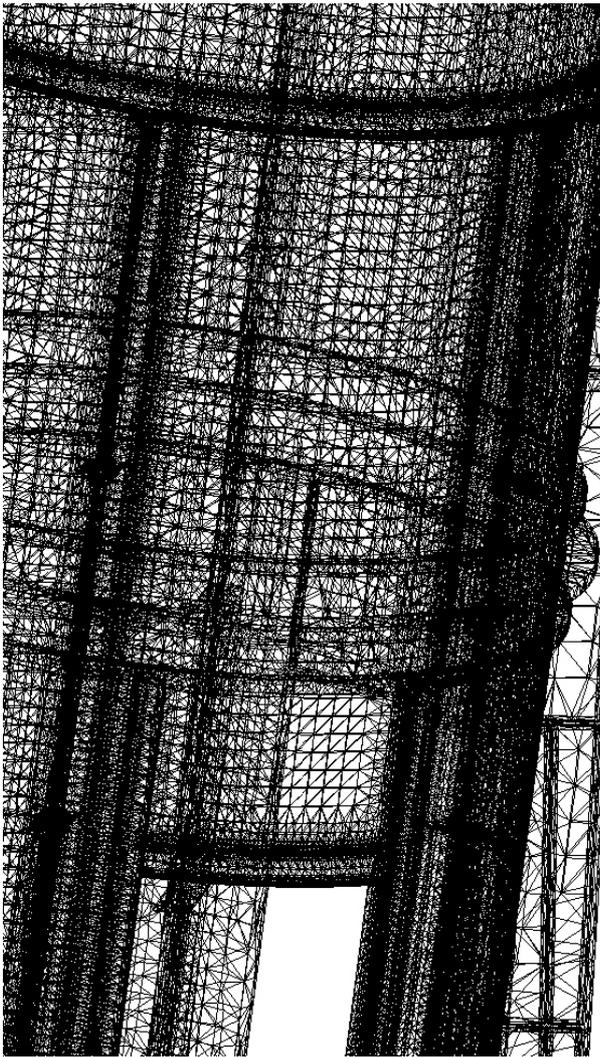
Figure 10. Detail of the mesh in the failure zone

Maximum values of uniaxial stress are obtained at the chimney's root section in the zones next to the upper corners of the flue duct entries, Fig. 12. High values of uniaxial stress are obtained at the outer wall just above the stiffening ribs.
