# Investigations on the Oxidation of Zn-coated Steel Cables

*The automotive component industry has been constantly being studying to improve its performance. Bowden cables are present in opening doors, moving windows and others. In braided cables formed by galvanized wires with Zn steel exposed to the usual environmental conditions, the generation of ZnO appears, a phenomenon known as "white corrosion". The investigation consisted of mitigating the causes of the ZnO formation. Scanning electron microscopy (SEM) and Electron Probe Micro-Analyzer (EPMA) technology, allowed to detect that the generation of ZnO was induced by the presence of nucleating elements of ZnO on the surface of the steel cable before galvanizing with Zn. The S, Cl and O became visible in the interface between coating and substrate. This allowed concluding, under the coating, there were harmful products capable of triggering the ZnO nucleation reaction. So, the storage and cleaning of the steel wire before galvanizing is essential to prevent the ZnO formation.*

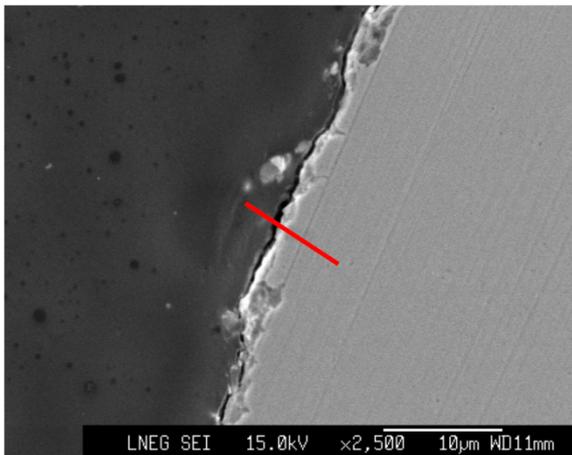
To understand whether these elements were on the outer face of the coating or on the coating/substrate interface, new analyzes were performed following a line (see figure 15) that runs through the coating, from the external resin used in the assembly process to the substrate.

Figure 15. Sample subjected to EPMA analysis following a line.

The results can be seen in figure 16, where four channels were used in order to divide the intensity and location of each element present along the line, considering that the left side of the images is the external resin and the right side the substrate of steel. Each channel was linked to a specific element: pink to O, cyan to Cl, green to S and red to Zn. Cl and O were present in the external resin (assembly process). After that, Zn became visible (coating layer) and S, Cl and O were again visible at the interface between coating and substrate. This ensures that, under the coating, there were harmful products capable of triggering the ZnO formation.
